MIDDLE SPRAGUE RIVER ASSESSMENT AND FUGATT PROPERTY CONCEPTUAL DESIGN

River Design Group, Inc.
5098 Highway 93 South
Whitefish, Montana 59937

August, 2006

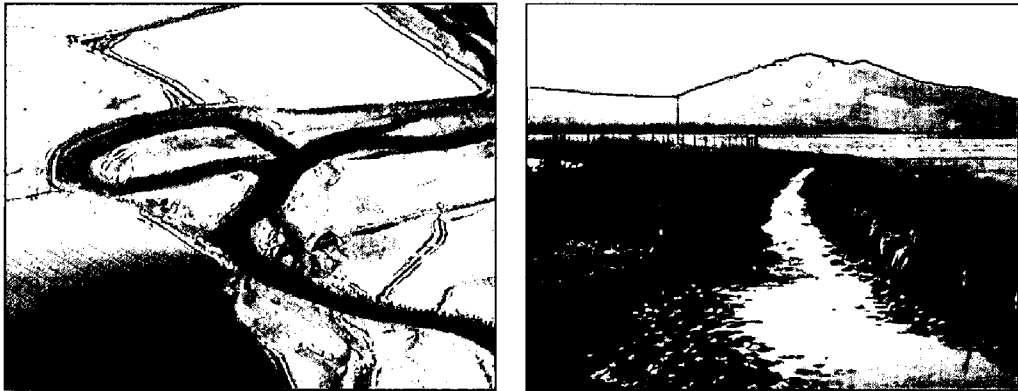
Figure 3-4. An abandoned meander on the Sprague River from station 285+00 to 286+00 shown in three dimensions from the LIDAR dataset (left). A ground photograph of the drainage/irrigation ditch paralleling the channel (right) illustrates the converted floodplain conditions. The red arrow on the LIDAR imagery denotes the direction and location of the ground photograph.

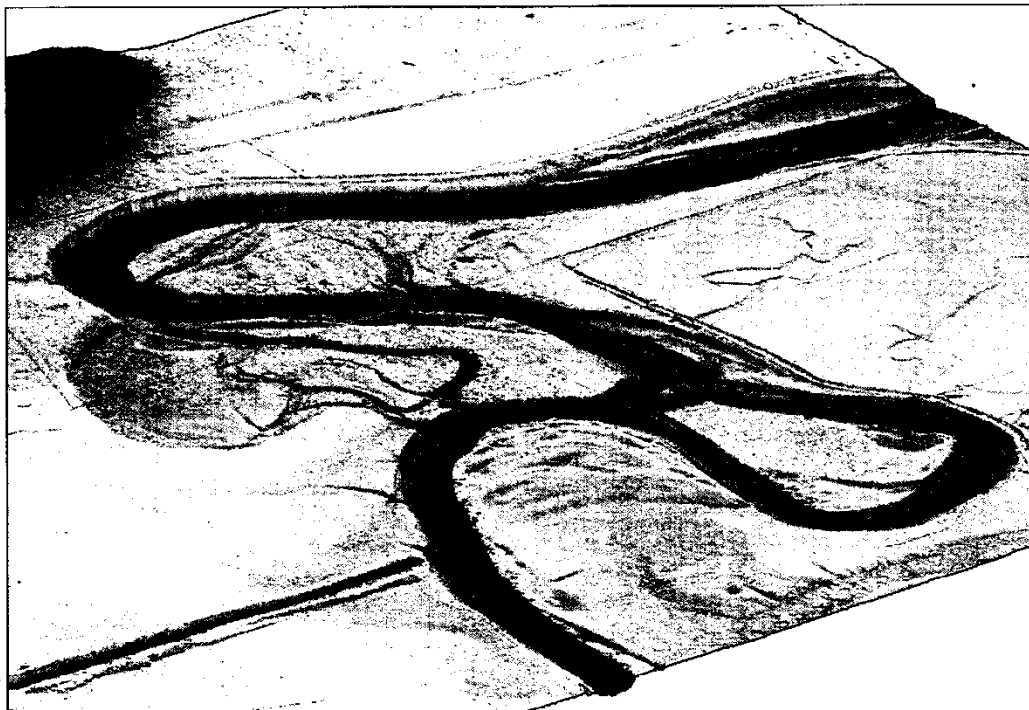
Upstream of the Fugatt property, the Sprague River has shortened in channel length since the 1940 air photo (Figure 4-1). The shorter channel has increased the energy gradient through the reach, reduced the availability of complex aquatic habitat, and increased water velocities. An expansive floodplain to the southeast of the current channel location suggests the river has migrated down-valley over time. Floodplain channels upstream and adjacent to the Fugatt property suggest dynamic channel-floodplain interactions during high flows.

Figure 4-1. A three dimensional view of the Sprague River upstream and through the Fugatt property. Floodplain channels and an abandoned meander suggest dynamic channel processes. The Fugatt property project area is highlighted by the red line.

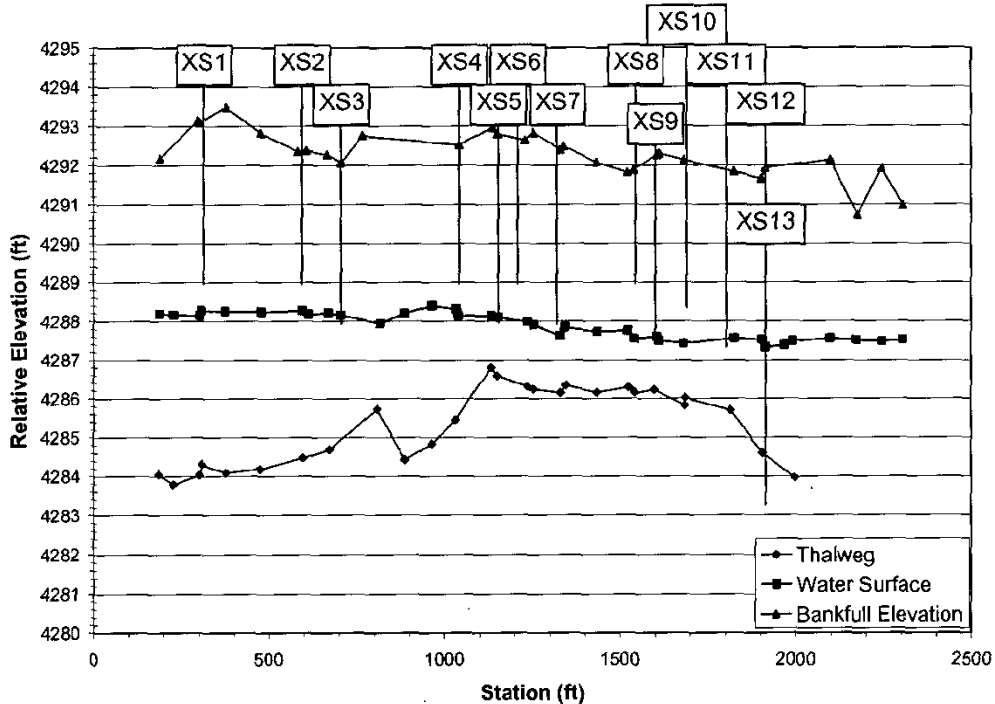
Figure 4-5. The channel profile through the Fugatt reach. The channel cross section locations are denoted by the numbered red boxes. The rise in the channel thalweg from station 11+50 through 18+25 shows where the clay hardpan forms the bed surface of the channel.

The bankfull channel slope is 0.0006 ft/ft. The water surface slope through the reach is 0.0004 ft/ft. The outside of the meander apex is the shallowest portion of the surveyed reach. The hardpan located through this section limits channel scour and pool formation.

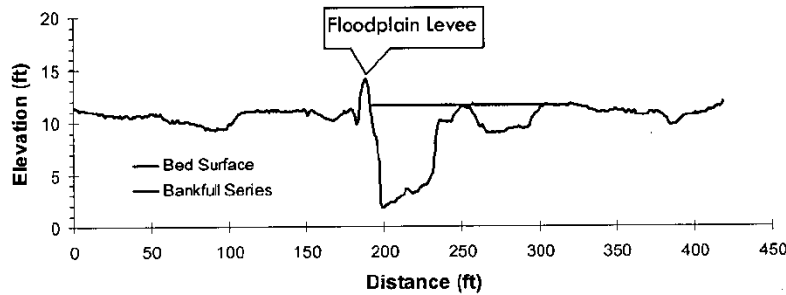
A floodplain levee, constructed after the 1940 air photo, disconnects the river from the adjacent floodplain in the downstream portion of the assessment area. The levee was constructed to improve agriculture and grazing on the Sprague River floodplain by reducing floodplain inundation during spring runoff and periodic rain-on-snow events.

Figure 5-3. Cross section 13 located at the downstream portion of the assessment reach illustrating the channel cross section and the floodplain levee. The levee disconnects the river from more than half of the floodplain. The channel cross section only shows a small portion of the left floodplain. The floodplain climbs in elevation at approximately Station 450 ft and reaches the Sprague River Highway at approximately Station 600 ft. See Figure 3-5 for the cross section location.

Addressing the levee will require a more detailed evaluation of the structure and its influence on the river and adjacent properties. Modifying the levee to allow floodwater access to the floodplain behind the levee is recommended. Reconnecting the channel and floodplain would improve habitat diversity, improve floodplain water storage, and likely reduce downstream flood elevations during high water events. Improving floodplain connectivity would also benefit floodplain forage and potentially reduce early season irrigation needs.

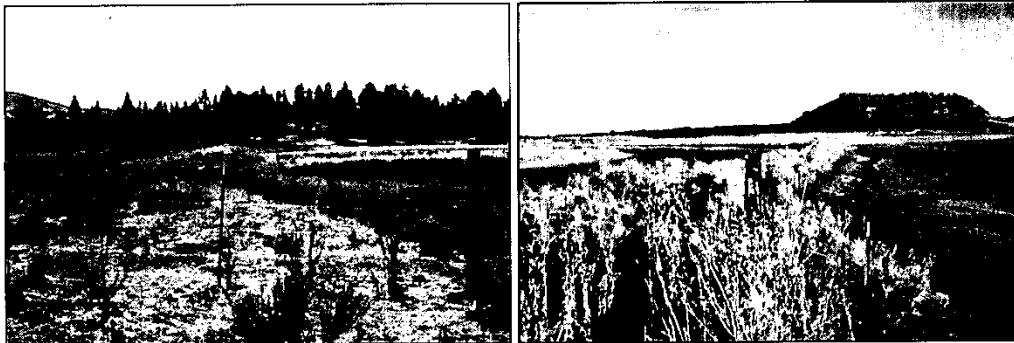
The levee has isolated the active channel from the floodplain, disconnected historical channel meanders, and degraded the riparian vegetation community (Figure 5-4). The fill material used to construct the levee is believed to have been excavated from the floodplain and channel. Invasive weeds occupy the levee surface.

Figure 5-4. Vegetation on the levee surface is dominated by noxious weeds and sagebrush (left). The levee disconnects the river from the adjacent floodplain in the downstream portion of the assessment reach.

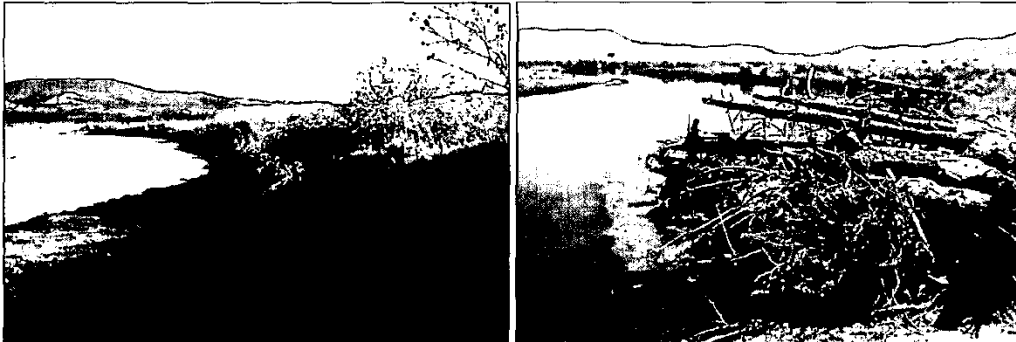
Figure 5-5. An example river corridor condition in the downstream portion of the assessment reach (left). A woody debris jam constructed on the Sprague River provides bank protection and diverse habitat for fish and wildlife (right).

Because the willow regeneration and beaver reintroduction process would likely take a period of time to occur, other measures may be employed to more quickly address the existing simplified aquatic habitat. Placing woody debris jams on channel margins is one method that has been used to increase habitat diversity on the Sprague River. Stable debris jams provide bank integrity and interstitial spaces for juvenile fish rearing. The resistance that debris jams create also promotes vertical channel scour and pool formation. These structures serve as a surrogate for streamside beaver lodges and willow thickets that historically provided aquatic habitat spaces and bank protection. Figure 5-5 shows an example portion of the Sprague River in the assessment reach as well as a woody debris jam constructed on the Sprague River near the Sycan River confluence.
