MIDDLE SPRAGUE RIVER ASSESSMENT AND FUGATT PROPERTY CONCEPTUAL DESIGN

River Design Group, Inc.

August, 2006

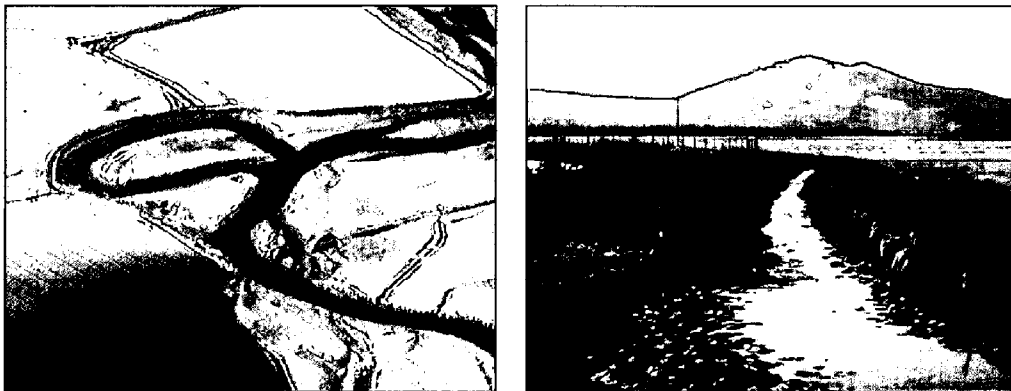
Figure 3-4. An abandoned meander on the Sprague River from station 285+00 to 286+00 shown in three dimensions from the LIDAR dataset (left). A ground photograph of the drainage/irrigation ditch paralleling the channel (right) illustrates the converted floodplain conditions. The red arrow on the LIDAR imagery denotes the direction and location of the ground photograph.

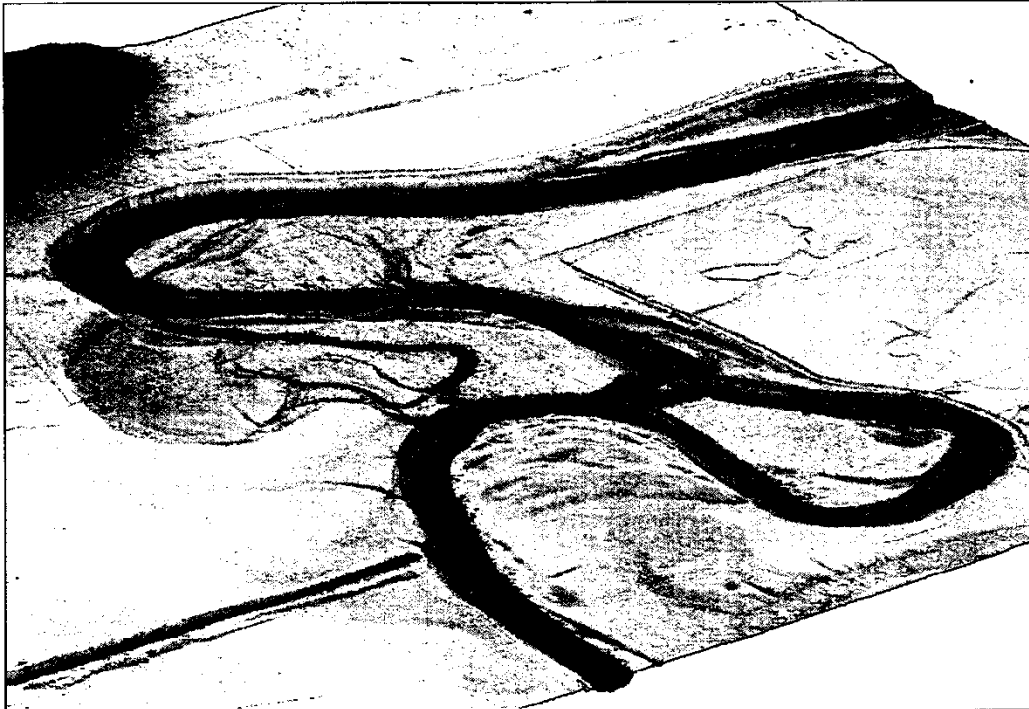
Upstream of the Fugatt property, the Sprague River has shortened in channel length since the 1940 air photo (Figure 4-1). The shorter channel has increased the energy gradient through the reach, reduced the availability of complex aquatic habitat, and increased water velocities. An expansive floodplain to the southeast of the current channel location suggests the river has migrated down-valley over time. Floodplain channels upstream and adjacent to the Fugatt property suggest dynamic channel-floodplain interactions during high flows.

Figure 4-1. A three dimensional view of the Sprague River upstream and through the Fugatt property. Floodplain channels and an abandoned meander suggest dynamic channel processes. The Fugatt property project area is highlighted by the red line.

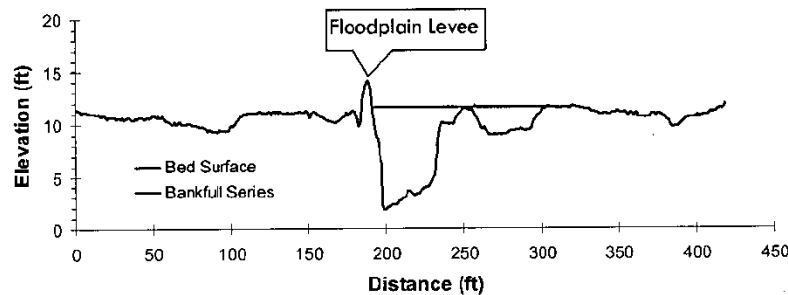
A floodplain levee, constructed after the 1940 air photo, disconnects the river from the adjacent floodplain in the downstream portion of the assessment area. The levee was constructed to improve agriculture and grazing on the Sprague River floodplain by reducing floodplain inundation during spring runoff and periodic rain-on-snow events.

Figure 5-3. Cross section 13 located at the downstream portion of the assessment reach illustrating the channel cross section and the floodplain levee. The levee disconnects the river from more than half of the floodplain. The channel cross section only shows a small portion of the left floodplain. The floodplain climbs in elevation at approximately Station 450 ft and reaches the Sprague River Highway at approximately Station 600 ft. See Figure 3-5 for the cross section location.

Addressing the levee will require a more detailed evaluation of the structure and its influence on the river and adjacent properties. Modifying the levee to allow floodwater access to the floodplain behind the levee is recommended. Reconnecting the channel and floodplain would improve habitat diversity, improve floodplain water storage, and likely reduce downstream flood elevations during high water events. Improving floodplain connectivity would also benefit floodplain forage and potentially reduce early season irrigation needs.

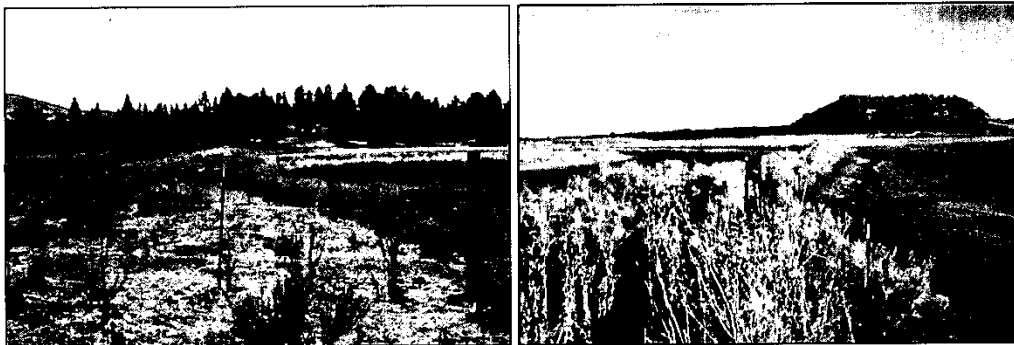
The levee has isolated the active channel from the floodplain, disconnected historical channel meanders, and degraded the riparian vegetation community (Figure 5-4). The fill material used to construct the levee is believed to have been excavated from the floodplain and channel. Invasive weeds occupy the levee surface.

Figure 5-4. Vegetation on the levee surface is dominated by noxious weeds and sagebrush (left). The levee disconnects the river from the adjacent floodplain in the downstream portion of the assessment reach.

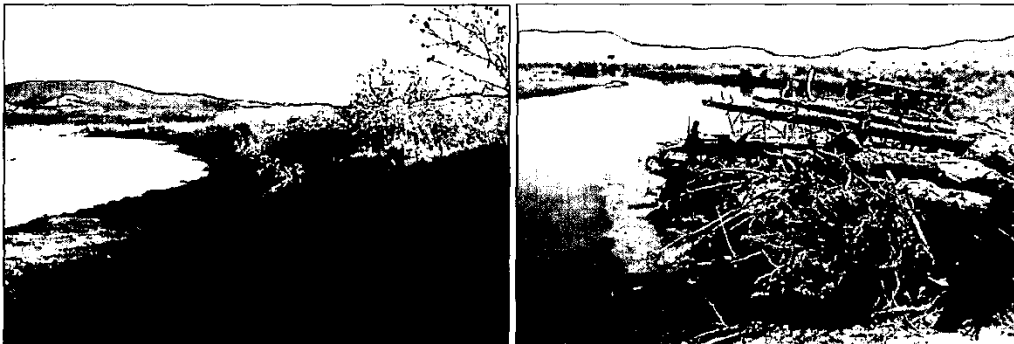
Figure 5-5. An example river corridor condition in the downstream portion of the assessment reach (left). A woody debris jam constructed on the Sprague River provides bank protection and diverse habitat for fish and wildlife (right).

Because the willow regeneration and beaver reintroduction process would likely take a period of time to occur, other measures may be employed to more quickly address the existing simplified aquatic habitat. Placing woody debris jams on channel margins is one method that has been used to increase habitat diversity on the Sprague River. Stable debris jams provide bank integrity and interstitial spaces for juvenile fish rearing. The resistance that debris jams create also promotes vertical channel scour and pool formation. These structures serve as a surrogate for streamside beaver lodges and willow thickets that historically provided aquatic habitat spaces and bank protection. Figure 5-5 shows an example portion of the Sprague River in the assessment reach as well as a woody debris jam constructed on the Sprague River near the Sycan River confluence.
