**GEOMORPHIC ASSESSMENT REPORT AND PROPOSAL FOR THE RESTORATION OF
THE SYCAN RIVER NEAR BEATTY, OREGON**

KRONENBERGER PROPERTY
BEATTY, OREGON

PROJECT NUMBER: 01-031

DECEMBER 20, 2001

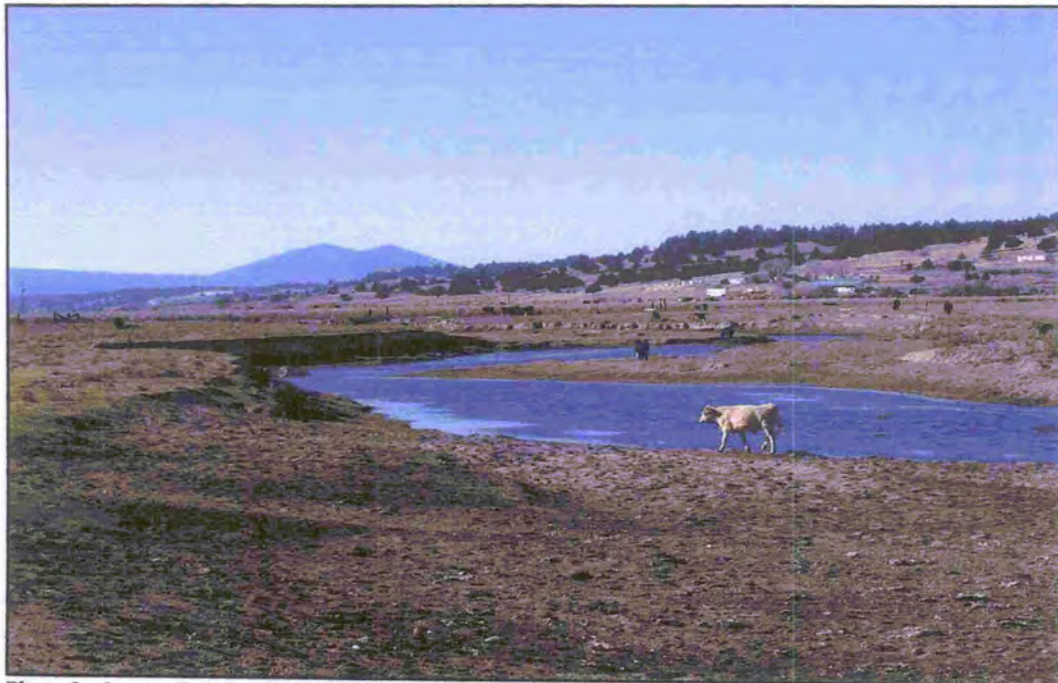
Photo 3. Lower Gowdawa Springs Reach. Note lack of bank and floodplain vegetation, accelerated bank erosion, poor riparian and instream habitat, and extremely high channel width : depth ratio. However, channel is not vertically entrenched and has access to a wide floodplain.

The processes are different in this reach of channel, probably due to the influence of the Sprague river floodplain. This reach has not downcut or degraded to the extent of the upper reach, but it is still somewhat entrenched. The entrenchment is more due to the excessive width:depth ratios rather than downcutting. All except the highest flood flows are mostly confined within the channel, providing more energy and shear stress than the streambanks can withstand. The result of these processes is for the channel to widen and straighten over time through erosion, lateral migration and finally, channel avulsion.

Data from the longitudinal profiles and cross sections indicate that the width:depth ratio ranges from 24 to over 60, the entrenchment ratio averages about 1.6 and the sinuosity is approximately 1.3. Channel substrate is predominantly sands and fine gravel. Stream type changes from a more entrenched F5 channel in the upper part of this reach transitioning into a C5 channel in the lower reaches. With appropriate width:depth ratios typical of an E type channel, the entire reach would have adequate access to the floodplain.

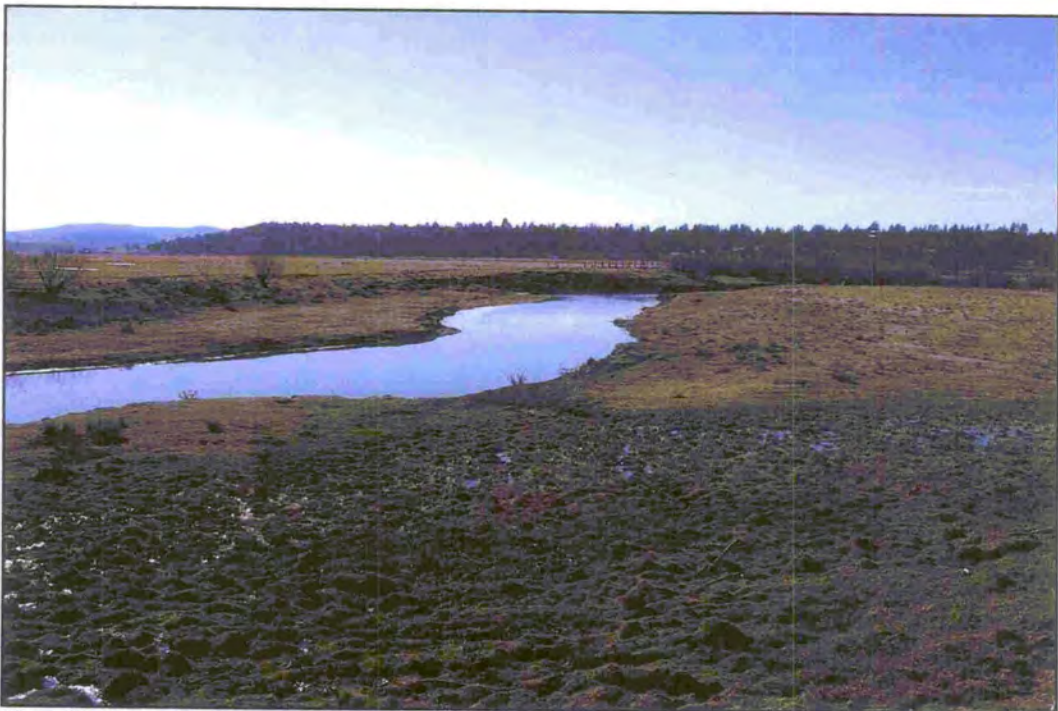
Photo 4. Lower Gowdawa Springs Reach. Typical view of lower reach demonstrating lack of riparian vegetation, poor habitat complexity, and extremely high width – depth channel ratios.

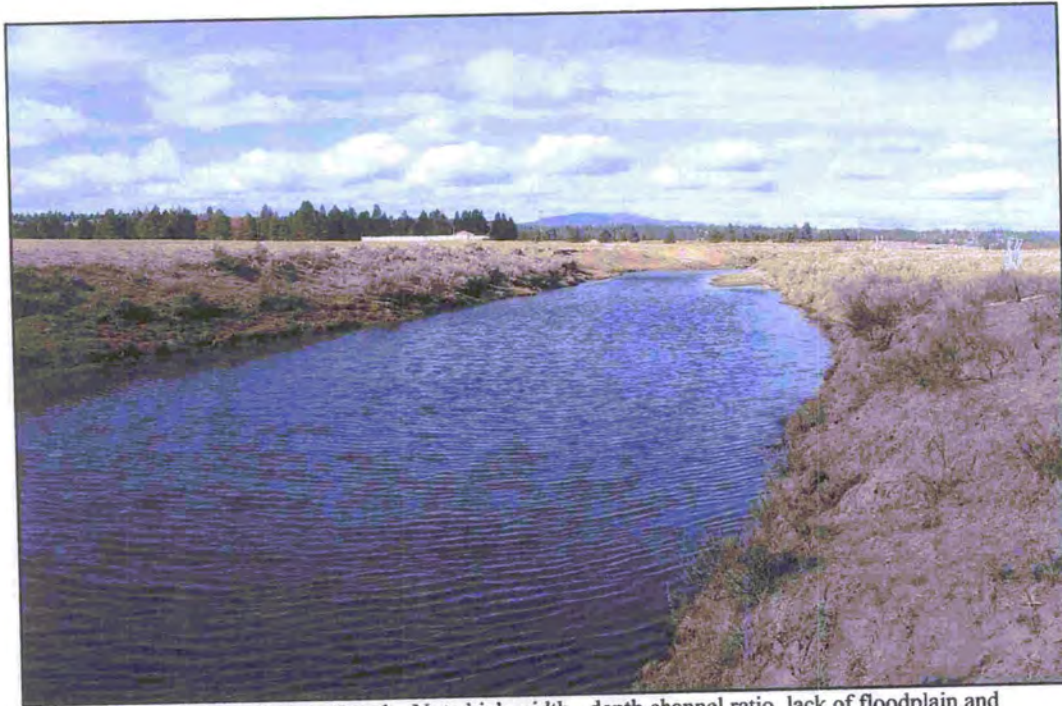
Photo 1. Upper Brown Springs Reach. Note high width - depth channel ratio, lack of floodplain and poorly established riparian community due to channel incision and overgrazing.

Vegetation within the floodplain is almost non-existent with the exception of grasses starting to colonize the narrow floodplain benches. The upper banks are almost continually eroding along both sides of the stream and the upper banks and terraces are vegetated with grasses, noxious weeds and sage. The most likely trend for this stream in its current condition and management

Data from the existing longitudinal profiles and cross sections indicate that the width:depth ratio ranges from 26 to 33, the entrenchment ratio averages about 1.3. The stream has an extremely flat gradient of 0.0003 ft/ft and a sinuosity of 1.27. The channel substrate is predominantly sands and silts with some small gravel.

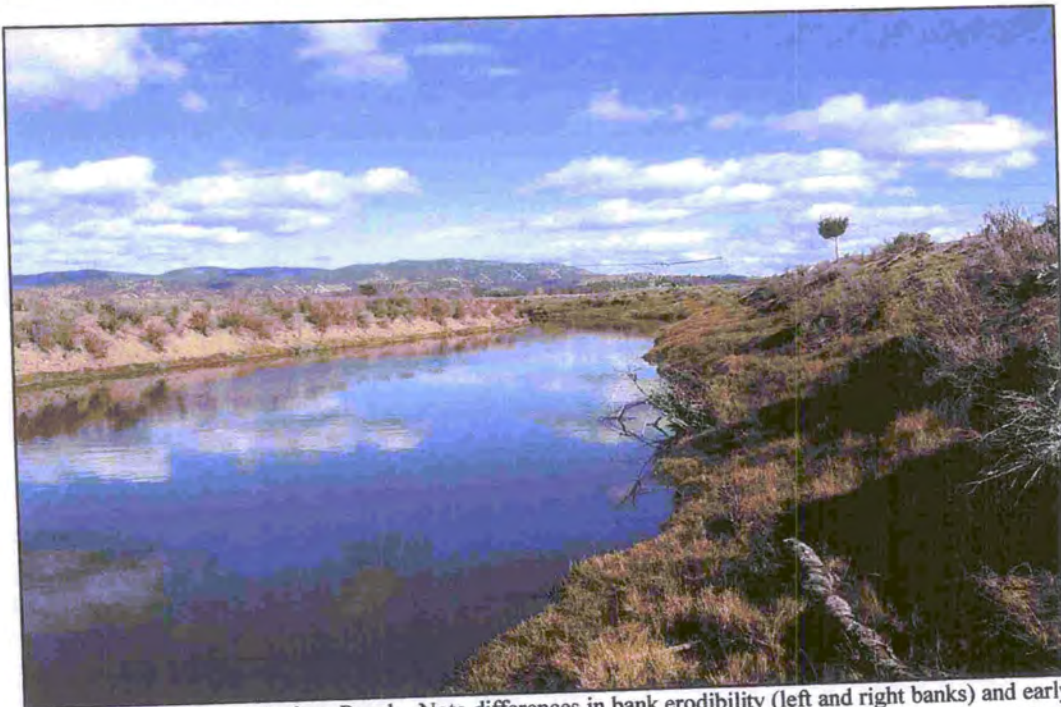
Photo 2. Upper Brown Springs Reach. Note differences in bank erodibility (left and right banks) and early establishment of natural bankfull floodplain on right bank (view upstream). This channel reach is entrenched and lacks adequate floodplain width to dissipate flood flows, resulting in high near bank stress and accelerated lateral erosion.

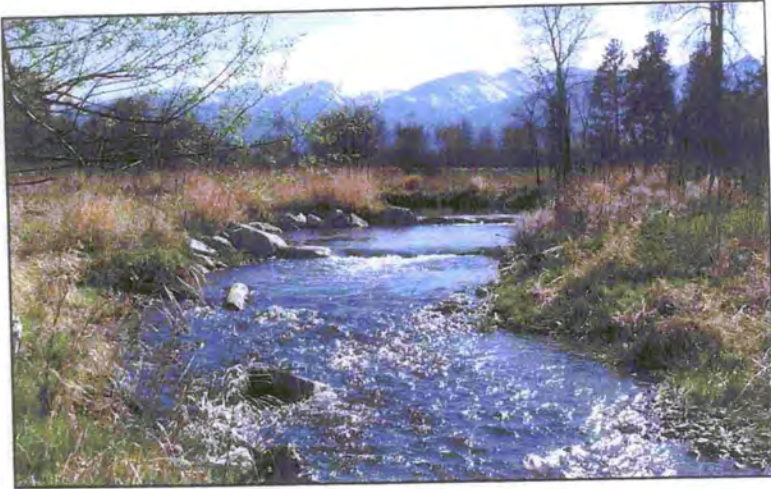
A low gradient step pool built to improve fish habitat and to provide grade control in the project area. The three pool structure provides for fish passage and sediment transport.

Alternative 1 would replace the existing outlet structure with a step pool structure as shown in Appendix B. The structure is made of native rock and designed to allow fish to leap from one pool to the next to provide passage. These structures have been effective for salmonids, but may not allow fish passage for other species. The road would need to be shifted downstream about 50 feet and a large squash culvert installed with the invert countersunk into the new streambed. The existing pond would be left in place and would continue to increase water temperature. However, the restored stream and riparian area would probably reduce existing temperatures slightly. Approximately 2 acres of wetlands would also be enhanced with this alternative. Total restored stream length would be about 4600 feet.

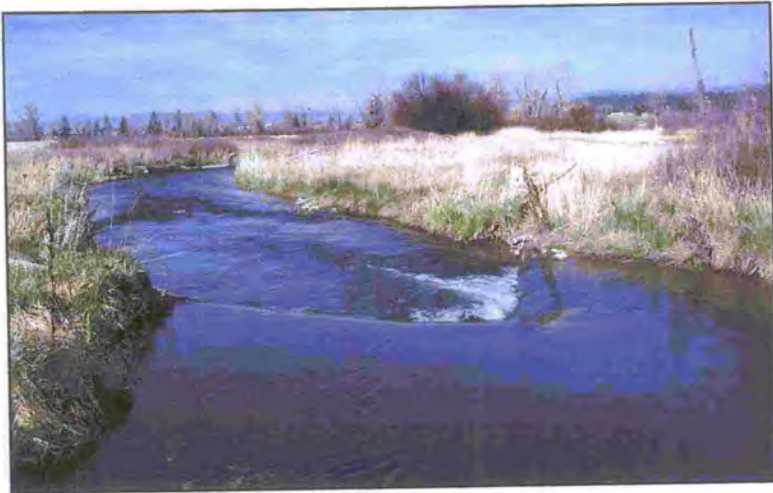
A log weir focuses the flow towards the middle of the channel. The weir protects the banks both upstream and downstream of the structure. A tear drop-shaped scour pool that forms downstream of the structure provides valuable fish habitat. Gravel sorting upstream of the structure provides spawning opportunities for salmonids.

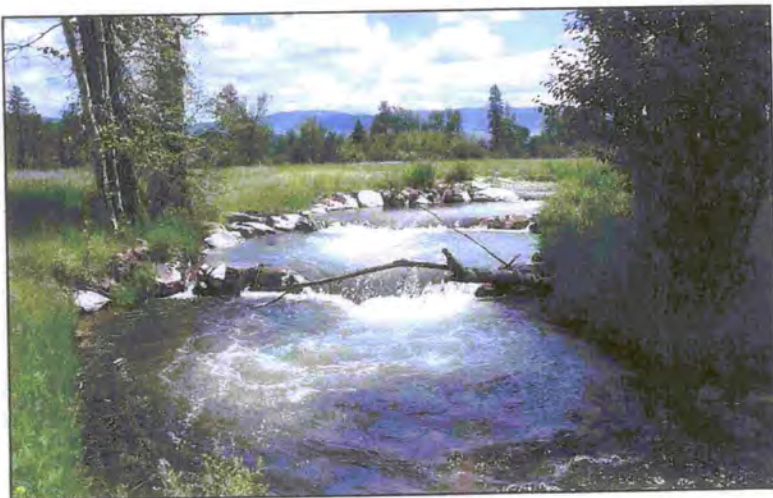
A three step, step pool structure was built to replace a shallow riffle that had been stabilized with riprap. The step pools provide habitat for both adult and juvenile salmonids. Complex currents through the pools offer both resting and feeding stations. The structure provides for fish passage and sediment transport.

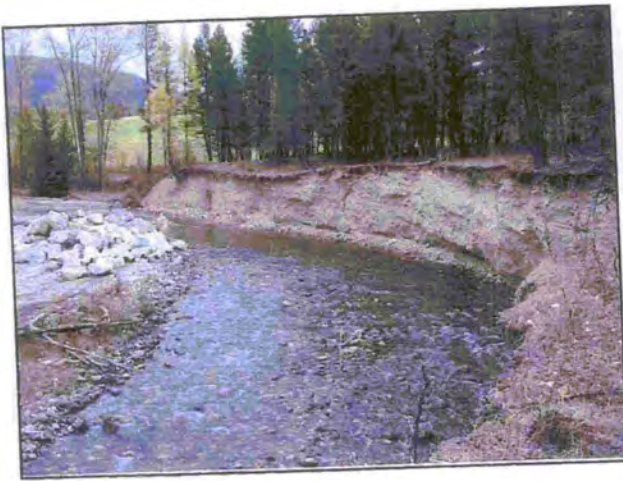
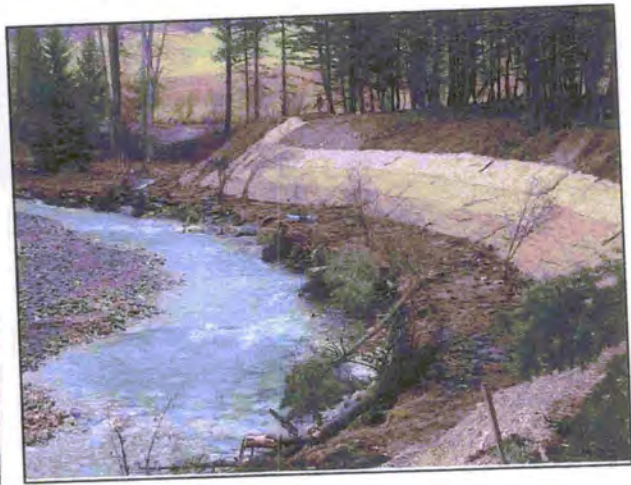
To reduce sediment inputs from an eroding terrace, WCI constructed a bankfull bench. The bench serves as a vegetated buffer separating the eroding terrace and the stream. The channel was also modified to increase complex pool and riffle habitats along the outside of the meander. The bankfull bench is useful for narrowing overwidened channels. When built with bank stabilization and fish habitat structures, fish habitat in the stabilized reach is greatly improved.

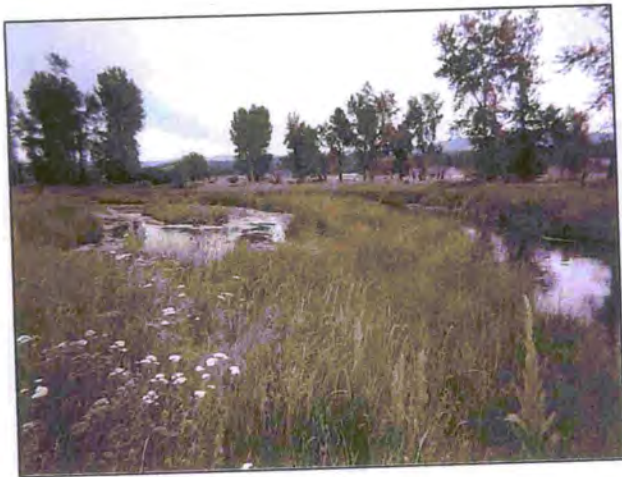
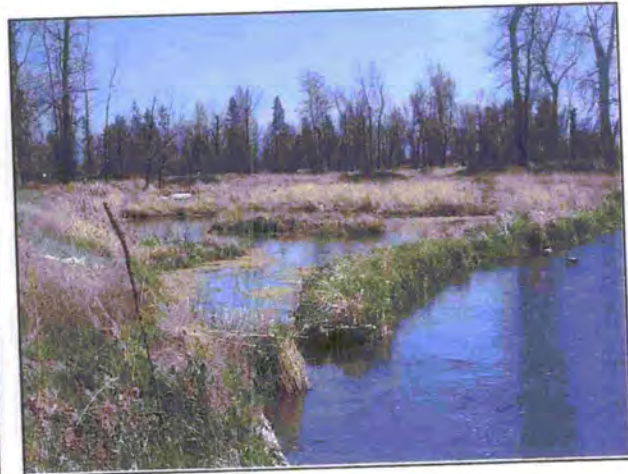
Finger bars are built to narrow the stream width and increase channel diversity. Finger bars are usually built on the inside of the meander where shear stresses are lower during high water periods. The created slackwater habitats benefit waterfowl and provides optimal conditions for juvenile fish rearing.

Alternative 3 would construct a 40 to 50 foot wide 'E' channel with a 100 to 120 foot wide base floodplain (low stage floodplain). The sinuosity would be approximately 1.6, which would increase channel length and sinuosity appreciably over existing conditions. Total proposed channel length would be about 14,400 feet. There would need to be some reshaping of the existing channel and a few short segments of new channel to achieve the desired result. Some of the excavated material could be used to create the bankfull benches and "finger bars" to narrow the channel. The total amount of fill can be minimized by excavating the proper channel depth and using this material to create a "finger bar" or partial point bar on the inside of the meander. This bar divides the main channel from a slack water area on the inside of the bend that is not connected to the stream directly (see Appendix B for an example of finger bar construction).
