Ex. 277-US-418

Stream: Williamson River

Survey Type: ODFW Stream Habitat

Access: Canoe Reach:1 (Units 1-8) Start:T35S-R07E-S30NE Quad: Agency Lake Date Surveyed:3 August 04

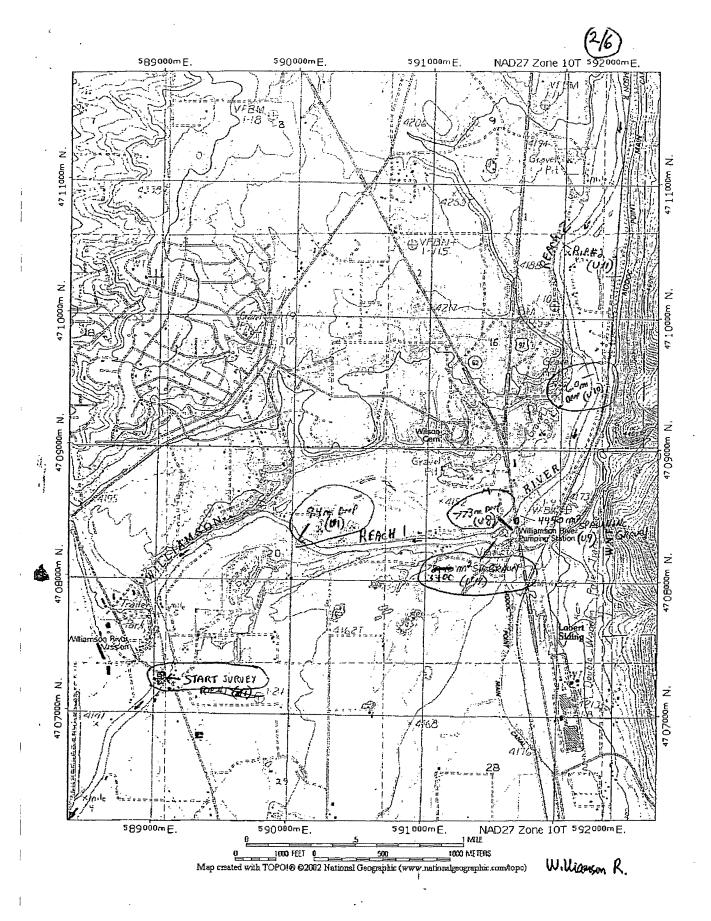
Due to very low stream gradient, the reach consists of 4 scour pools or glides up to 1,990 m long, separated by relatively short riffles (22m-130 m). Maximum depths were surprisingly deep (9.4 m) and have the potential to hold large numbers of spring Chinook (Map). Residual depths averaged 3.9 m. A lateral scour pool below Highway 97 (U8) is at least 3 m deep (possibly much deeper) and is strategically located between 2 riffles with large areas of spawning gravel (see map).

Photo 29 Unit 3 The reach was dominated by long deep pools or glides with maximum depths up to 9.4 m.

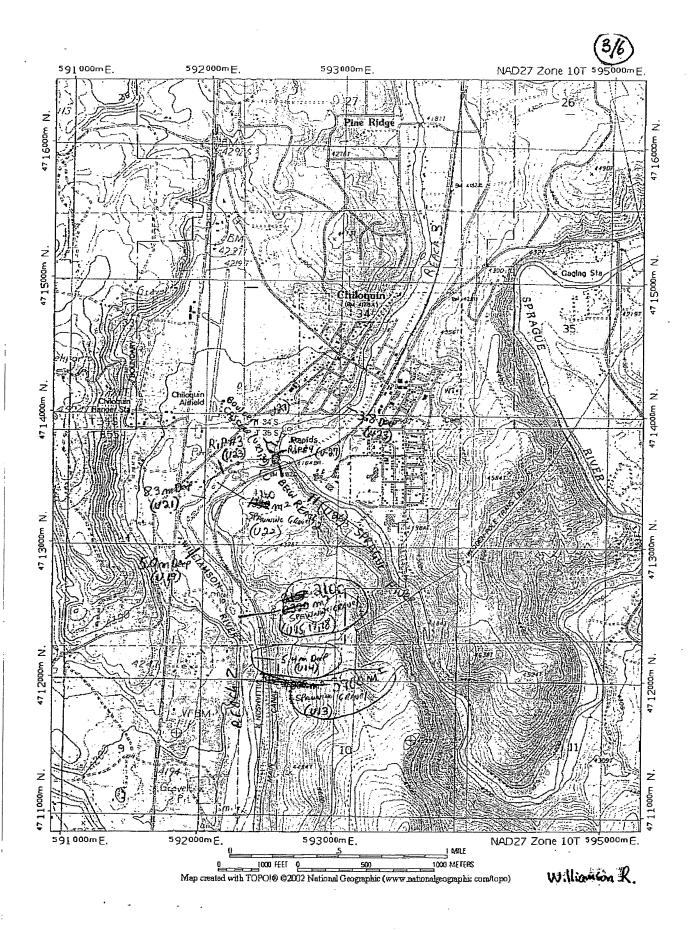
Spawning gravel was concentrated in riffles which were 38 percent gravel and 33 percent cobble. Surveyors visually estimated that a total of 3,505 m² of gravel/cobble was suitable for Chinook salmon spawning at existing low flows. About 3,400 m² of the gravel (97%) was in 2 riffles immediately below the Highway 97 bridge (U4,U5; Photo 30). High amounts of sand/organics in riffles (24%) reduces the quality of gravel for spawning.

Photo 30 Unit 4
Riffle below Highway
97 bridge had 3400 m²
of gravel/cobble suitable
for Chinook salmon
spawning. The deep
pool above riffle atwater
intake structure is
excellent adult holding
water.
