ANDERSON SPRING CREEK RESTORATION PROJECT DESIGN REPORT

WCI Project No. 02-012

May 31, 2002

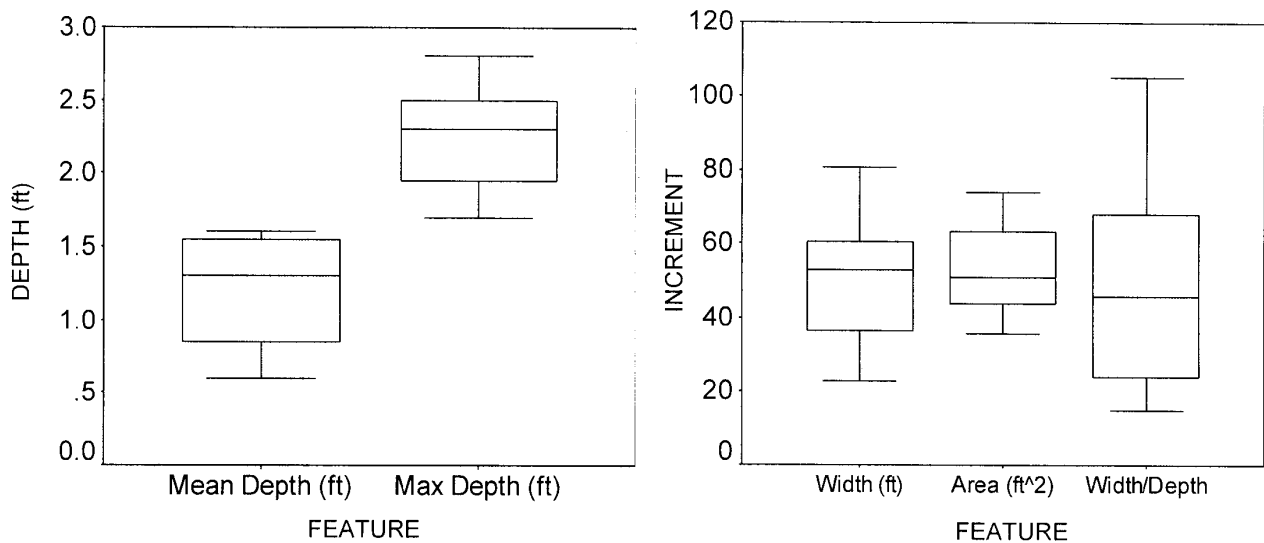
Figure 2: Box plots illustrating the bankfull channel metrics for the riffle cross-sections measured on Anderson Spring Creek (n = 11).

Fourteen cross-sections were surveyed in the project area. Eleven cross-sections captured riffle/glide habitat units, as these habitats dominated the project area. Three cross-sections were located to capture the two pools in the project reach. The dominance of riffle/glide habitat and the low pool frequency reflects the poor fish habitat condition of the spring creek.

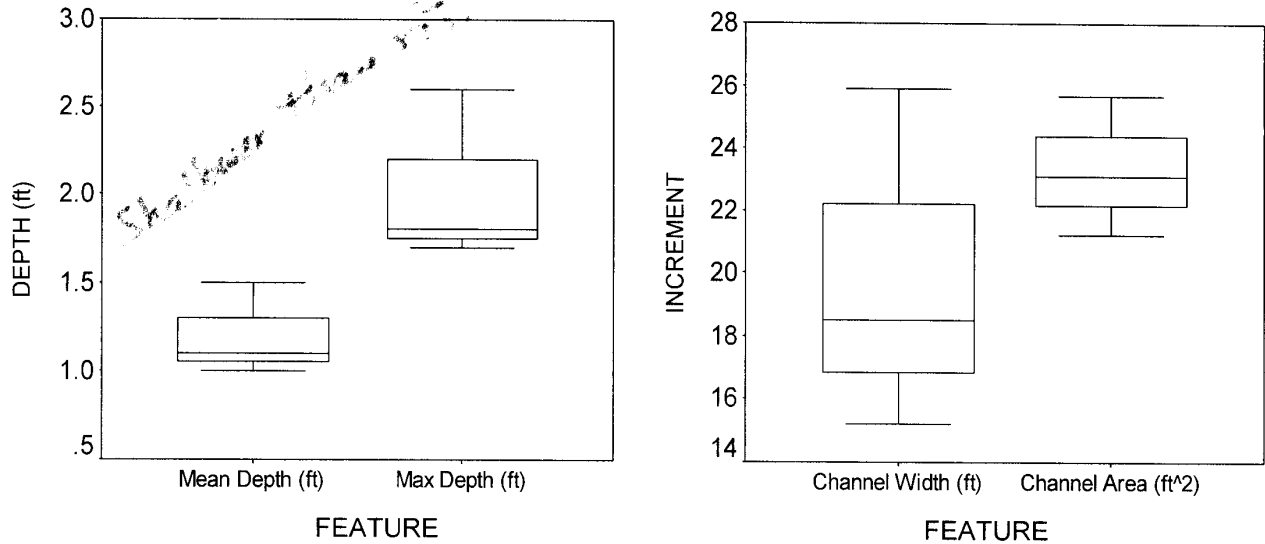
Figure 3: Box plots illustrating the bankfull channel metrics for the 14 cross-sections measured on Anderson Spring Creek.

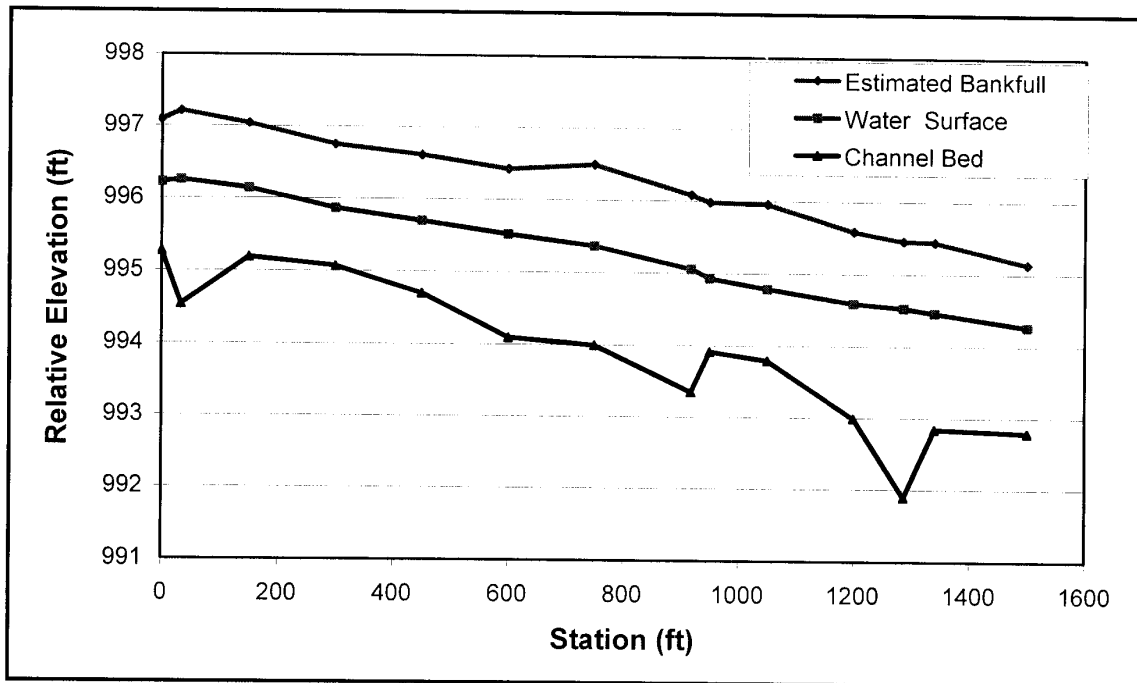
Figure 4: The Anderson Spring Creek project area longitudinal profile.

The longitudinal profile illustrates the low pool frequency in the project reach (Figure 4). Two primary pools were located at the beginning, and towards the bottom of the project reach. The remainder of the project area was characterized by low gradient riffle/glide habitat.

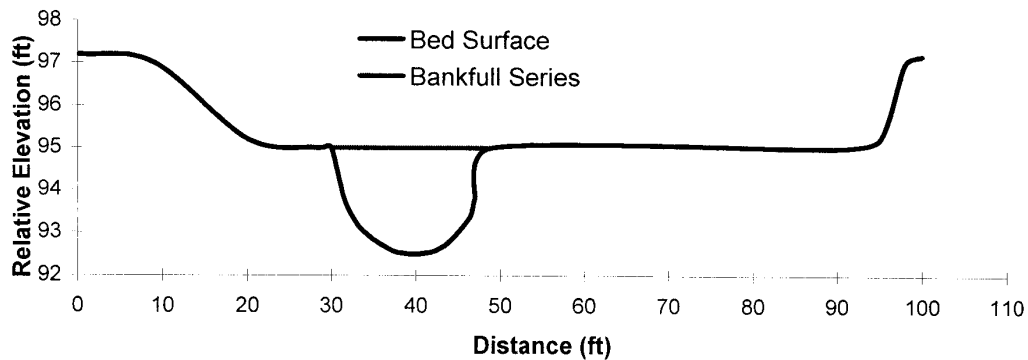
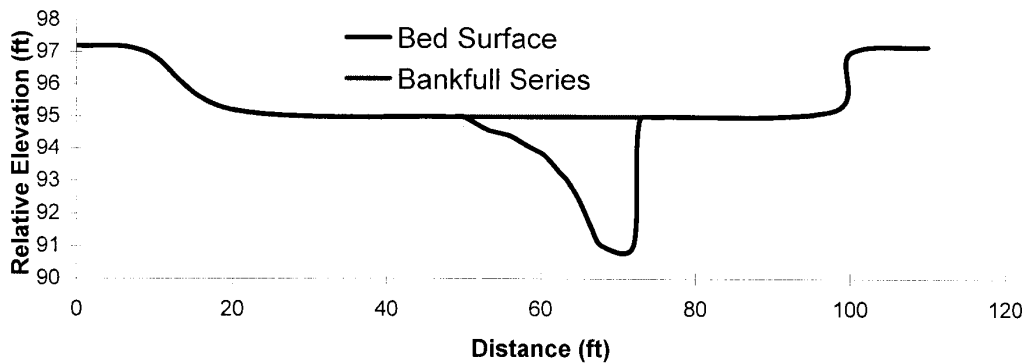
Proposed Typical Riffle Cross-Section

Proposed Typical Pool Cross-Section

Figure 5: The proposed typical riffle and pool cross-sections for the outlet channel restoration project. Note the vertical exaggeration in both cross-sections.

The proposed channel design dimensions were modeled in WinXSPro to determine the bankfull channel capacity and sediment transport properties. Flow measurements completed in the field were used to calibrate the hydraulic model and refine the bankfull discharge estimate. Table 5 includes the typical (impaired), stable, and design channel dimensions for the Anderson Spring Creek project site. Figure 5 illustrates the proposed typical riffle and pool cross-sections for the Anderson Spring Creek.

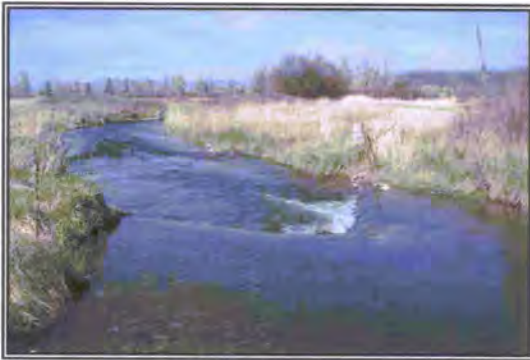
Figure 6.1: A log weir provides fish habitat and directs the thalweg towards the center of the channel, reducing lateral bank erosion and sediment contributions.

The proposed structures for streambank stabilization and grade control include bank placed rootwad revetments, high-stage deflector logs, log vanes, log weirs, and cobble patches (Figure 6). Revetment structures including rootwads and trees typically have a lifespan of between 15 and 20 years. The intent of these wood structures is to provide short-term interim protection and habitat until mature, stabilizing vegetation becomes established on streambank and floodplain areas. Woody debris provides native complex habitat with a relatively long lifespan over the entire range of flows. Proper placement of woody debris in the channel will improve channel stability in addition to habitat quality.

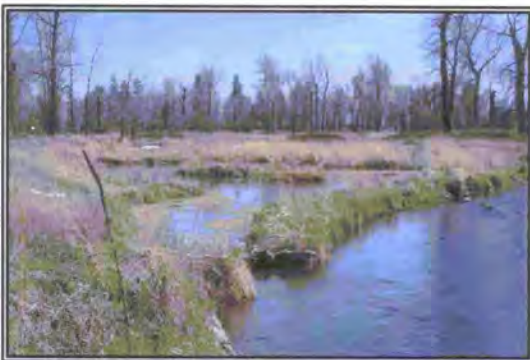
Figure 6.2: Finger bars are effective for narrowing over-widened channels. These structures require minimal fill material and create off-channel pond habitats. Off-channel habitats may benefit juvenile shortnose and Lost River suckers out-migrating from Anderson Spring Creek. The ponds also benefit waterfowl.

Wetland plugs and finger bars will be constructed to separate the reconstructed and existing channel (see Figure 6.2). These features will be constructed using fill material and harvested sod mats. Mature willow transplants will be used to stabilize each of the wetland plugs. Additional shrub planting and sprigging will improve plug integrity and speed the integration of the plugs with the surrounding floodplain. Finger bars will be constructed where the existing channel is greatly over-widened and filling the entire channel would require a significant amount of fill material. Finger bars effectively reduce the cross-sectional channel area and provide off-channel aquatic habitat for waterfowl and juvenile fish. Wetland plugs and finger bars will increase the habitat diversity and channel stability in the project reach.

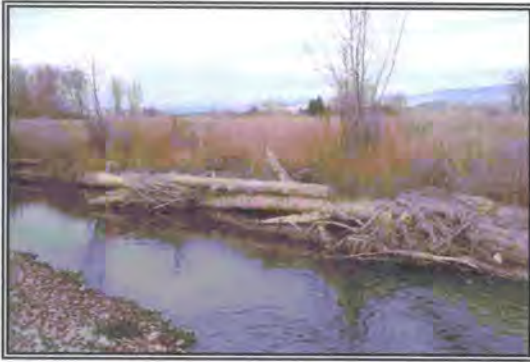
Figure 6.3: Bank stabilization/fish habitat structures are constructed with native materials including rootwads, deflector logs, and vegetation. Structures span from the scour depth to the bankfull elevation. Structure complexity benefits all age-classes of the target fish species. Young-of-year and juveniles use interstitial spaces while adults inhabit the deep scour pools that are formed around the rootwads.

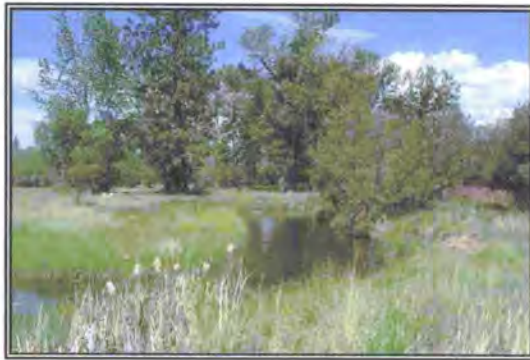
Figure 6.4: Constructed floodplains are necessary for narrowing over-widened channels. Fill material is used to narrow the channel. Sod and willow transplants speed the stabilization and recovery of the constructed floodplain. The narrowed channel improves sediment transport, flow conveyance, stream temperatures, and fish habitat condition.

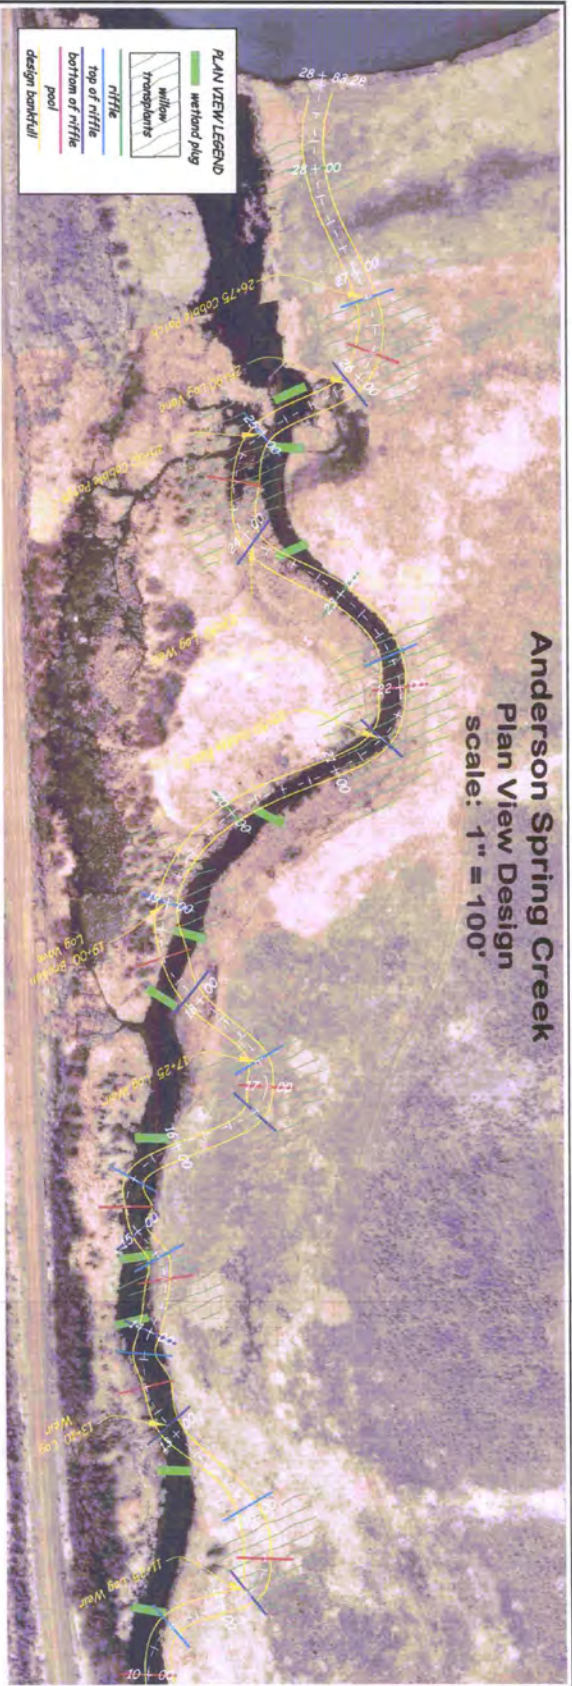
Figure 7a

Anderson Spring Creek
Plan View Design
 scale: 1" = 100'

Longitudinal Profile

The restored Anderson Spring Creek will be a self-maintaining channel capable of conveying the range of flows and transporting the sediment made available by the watershed (Figure 7). The channel restoration design accounts for two primary tributary spring creeks that influence Anderson Spring Creek. Portions of the tributary spring creeks will be relocated to accommodate the designed channel location.
