OREGON DEPARTEMNT OF FISH AND WILDLIFE
CENTRAL REGION ADMINISTRATIVE REPORT
No. 86-1

Fivemile Creek Stream and Riparian
Restoration Project
Progress Report

By
John D. Fortune, Jr.
District Fish Biologist
Klamath District

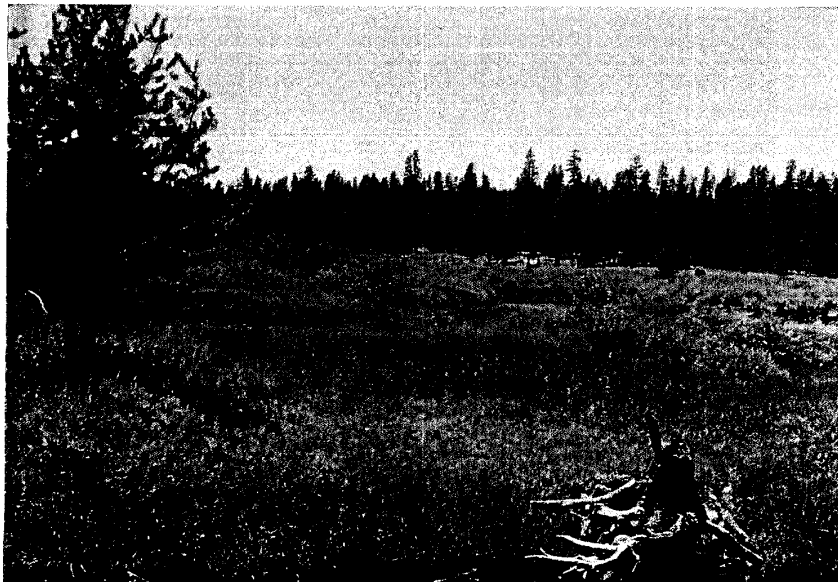
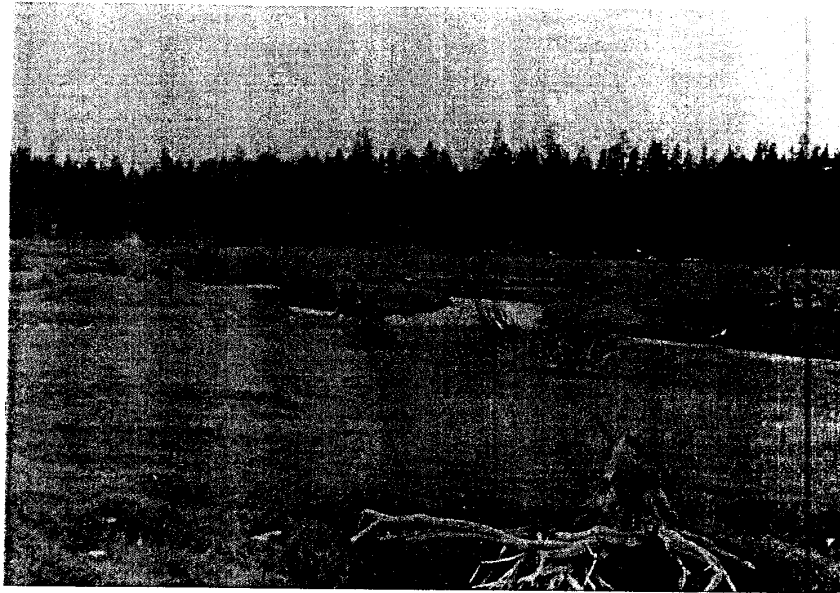
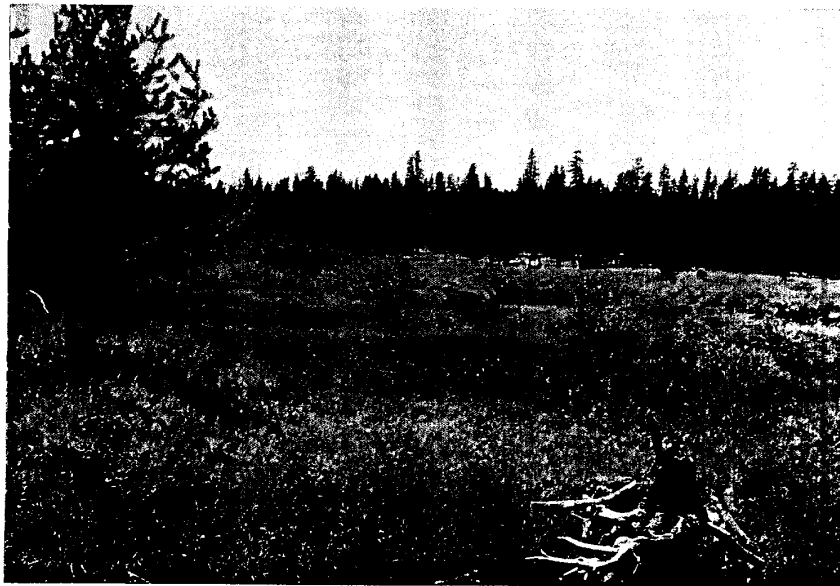
Figure 2. Photopoint 5 downstream overview from downstream portion of Exclosure A-2.

Figures 2, 3 and 4 are pictures from selected photo-points showing pre-project conditions compared to those in the summer of 1986. Figure 2 is an overview showing the overgrazed condition in 1975 with dead clumps of willow, exposed stream banks lacking vegetative cover. The 1986 photo is not totally comparable because it was taken during the growing season, but it does show much better conditions of the vegetation including the ground cover, stream-side cover and regrowth of willows.

Photo-points have been an excellent tool for showing the restoration process. They should be continued, at least at selected points and taken at times of the year that are comparable to the original photos November and August for A-Exclosure and July for B-Exclosure.

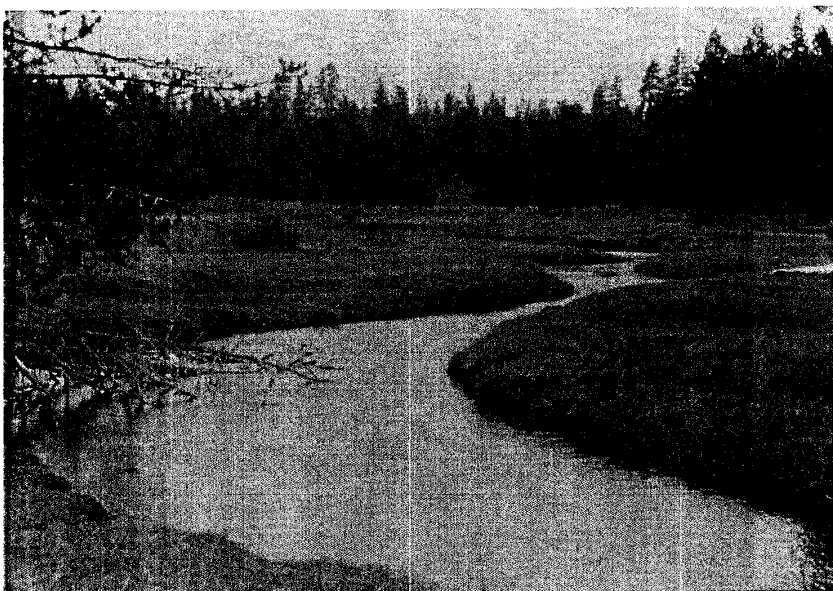
Figure 3. Photopoint 7 looking upstream into the downstream end of Exclosure B.

Figure 3 is also a November - July comparison but does illustrate the dramatic change at that location. The most obvious development is the growth of stream-side alder that is beginning to provide shade to the water and cover for fish. The growth and maintenance of sedges and grasses on the stream banks have trapped sediment leading to narrowing of the channel and providing cover for fish and shade over the water. The overhanging shrubs and sedges also provide a source of terrestrial insects for added fish food.

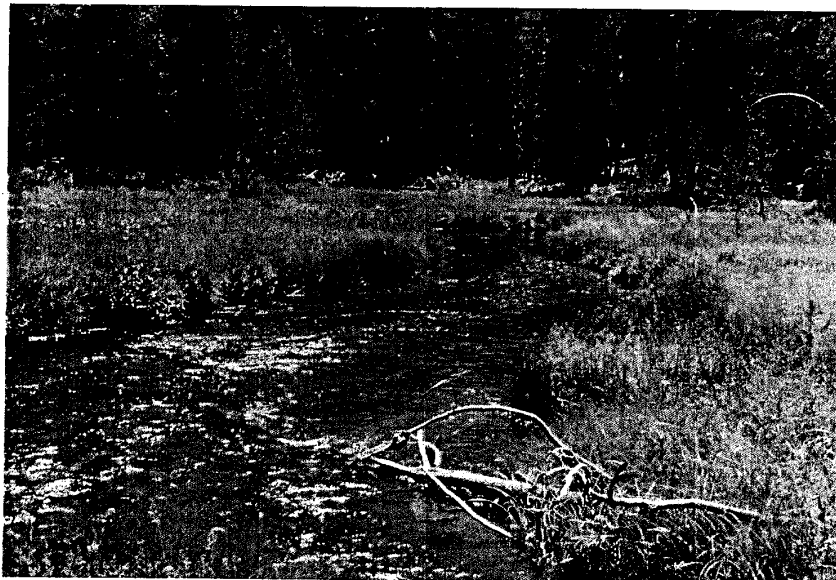
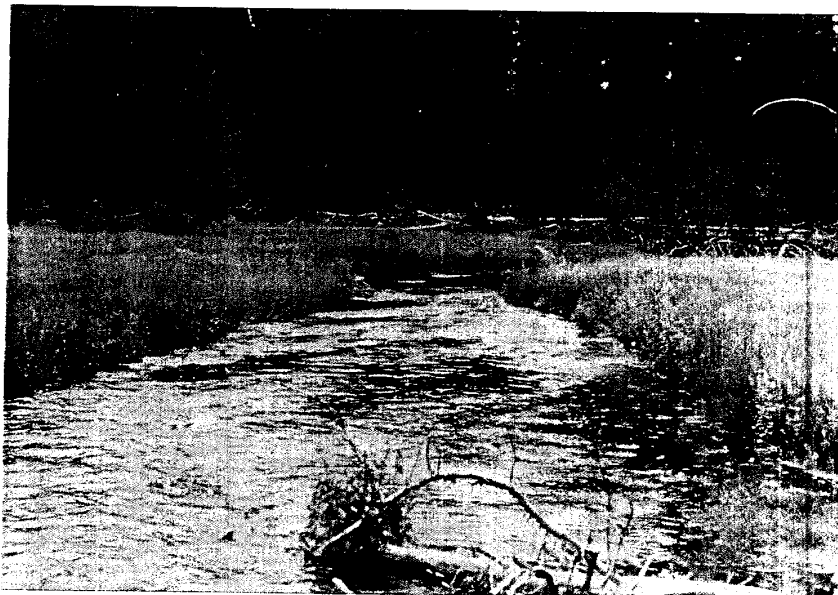
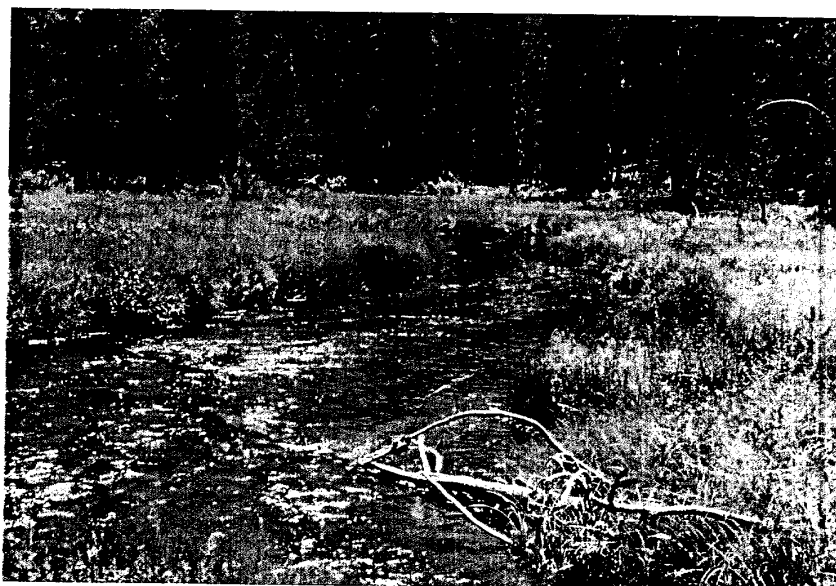
Figure 4. Photopoint 13 looking downstream into the upstream end of Enclosure B.

Figure 4 shows comparable photos after six years of protection and illustrates how ungrazed vegetation can trap sediment and build up stream banks there by narrowing, deepening and stabilizing the channel. The later condition offers better habitat for fish and better water quality.

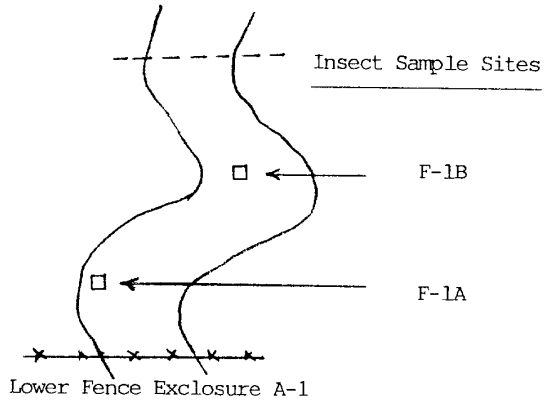
Figure 10. Locations of fish and insect sampling sites.

Sampling of the fish population was initiated as a method of evaluating the project. The three 100-foot sample sections are shown in Figures 2 and 10. The sampling attempted in 1976 was not successful because of problems with the electrofishing unit. The fish could not be captured effectively, but there were three species seen including five rainbow trout, up to about 9 inches, numerous speckled dace and sculpins.

Samples of aquatic insects were also taken with the intent of evaluating the project. Four sites, Figure 10, were sampled for insects with a square-foot sampler in 1976, 1979 and 1983. Those sample results are
