MIDDLE SPRAGUE RIVER ASSESSMENT AND FUGATT PROPERTY CONCEPTUAL DESIGN

River Design Group, Inc.
5098 Highway 93 South
Whitefish, Montana 59937

August, 2006

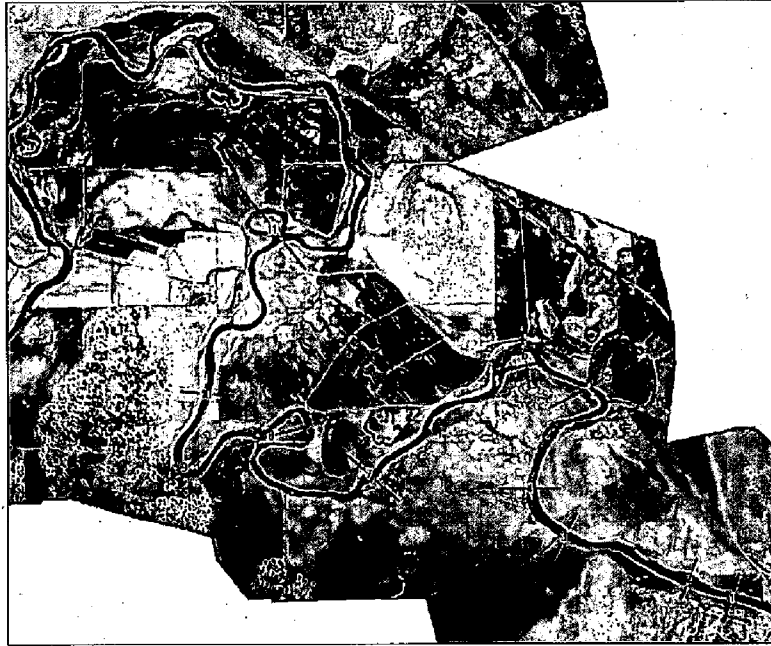
The existing channel morphology in the assessment reach was evaluated using the LIDAR dataset. Figure 3-5 shows the cross section location. Figure 3-6 illustrates example channel cross-sections. Table 3-4 compares the dimensions for the selected channel cross sections. In general, sampled locations characterized by a single channel had a smaller cross section area, narrower width, and a greater mean depth compared to multiple channel sites. Multiple channel sites were typically related to meander cut-off locations or where human activities had influenced the channel. Channel dimensions sampled from multiple channel sites generally had greater cross section areas, wider channels, and shallower mean depths. Maximum channel depths were similar between the two channel classes suggesting that flows maintain the maximum channel depth in both single and multiple channel locations. At three locations where the river has abandoned historical meanders (Cross section 5, Cross section 8, and Cross section 11), the historical channel segments have filled and the more recently formed avulsion channels maintain deeper and larger channels. Floodplain levees located on the west floodplain adjacent to the channel limits floodwater access to the floodplain.

Figure 3-5. The location of the channel cross sections in the assessment reach. Representative cross sections are provided in Figure 3-6.

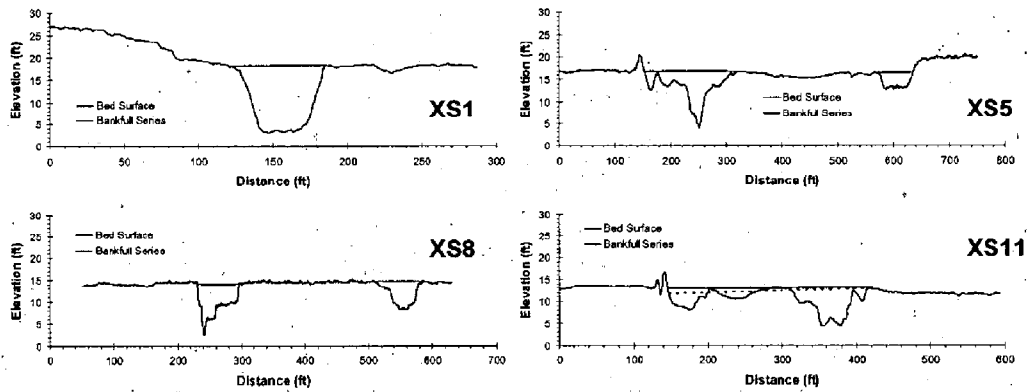
Figure 3-6. Example channel cross sections from the assessment reach. XS1 represents an example single channel location. The other cross sections have multiple channels. Floodplain peaks on the left bank of XS5 and XS11 are floodplain levees. The graphs are vertically exaggerated. The distance for XS1 is substantially shorter than the other cross sections and therefore the channel image is magnified.

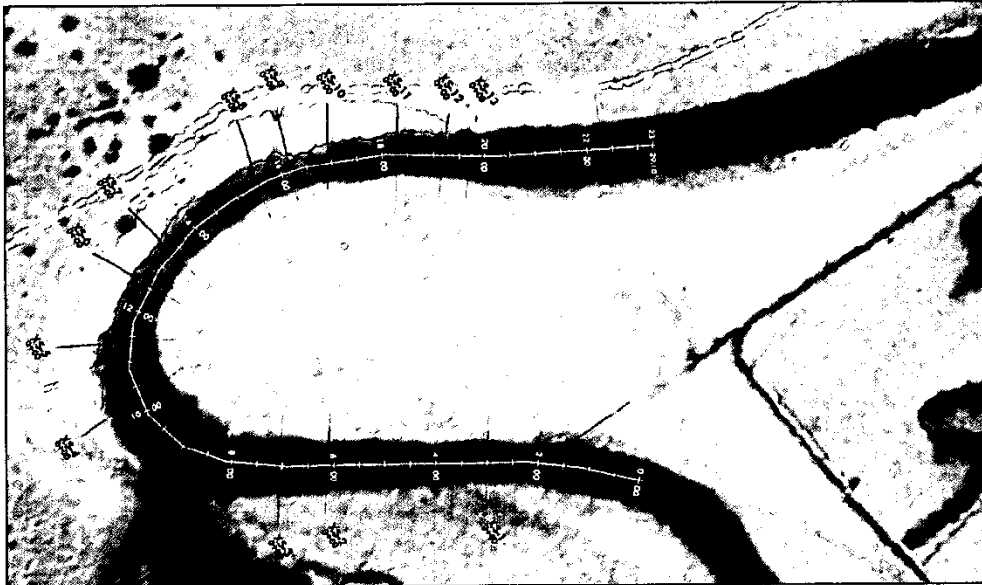
Thirteen cross sections were surveyed through the Fugatt property to characterize the existing channel conditions (Figure 4-3). Cross sections were located to evaluate the channel upstream of the terrace, through the terrace reach, and downstream from the terrace. In plan view, the channel width varies through the reach, especially at the start of the meander. The channel widening is associated with the interaction of the channel with the bedrock outcrop between Cross section 3 and Cross section 4. Table 4-1 displays the bankfull channel dimensions for each of the cross sections presented by subreach.

Figure 4-3. Channel cross section locations through the Fugatt reach. Cross sections were situated to evaluate the channel dimensions and how the channel dimensions adjust with the interaction with the clay hardpan from approximately station 11+00 to 18+00.

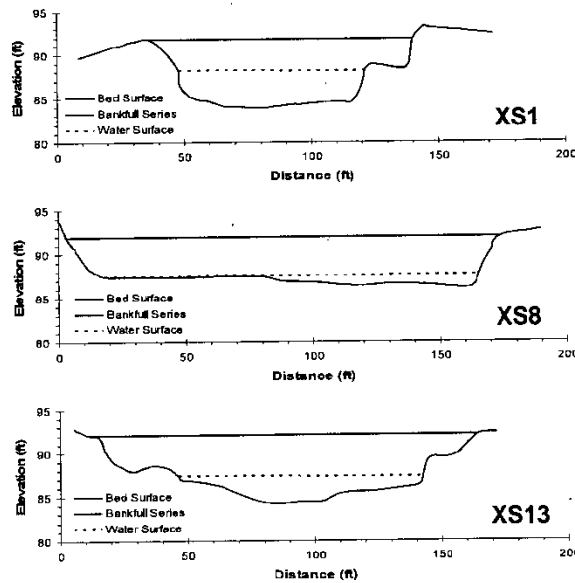
Typical channel cross sections representing the three sub-reaches are presented in Figure 4-4. Bankfull channel dimensions are presented in Table 4-2. Upstream of the meander, Cross section 1 is characterized by a narrow, deep channel with a vegetated bench below the bankfull elevation. Cross section 8, located downstream from the meander apex, has a wide, shallower morphology. The hardpan is exposed during low flows and does not support vegetation. The smooth surface of the hardpan also results in the efficient transport of bedload through the meander. Gravel in the reach is limited to the margin of the point bar. Cross section 13, located downstream of the terrace and hardpan channel feature, is again narrow and deep, similar to Cross section 1. The channel conditions through the property reflect the presence of the terrace and the hardpan.

Figure 4-4. Typical channel cross sections through the Fugatt property survey reach.

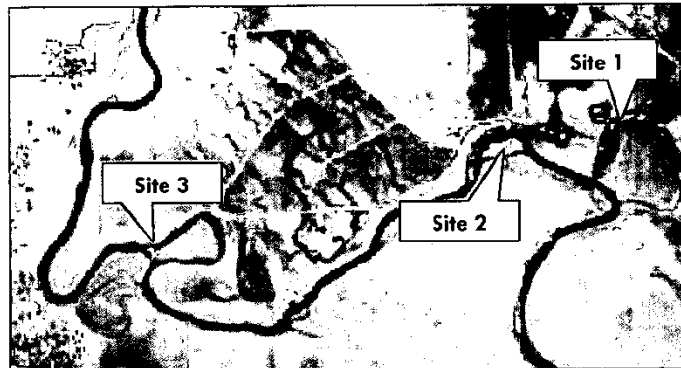
Site 1 was identified during the field assessment and occurs at station 120+00 in the project area (Figure 5-6). Based on the air photo analysis, the meander was disconnected from the primary Sprague River alignment between 1940 and 1998. However, by 1940, a majority of the primary flows were likely conveyed through the floodplain avulsion channel rather than the historical primary channel. The historical channel likely conveyed flow during all stages of the hydrograph. However, the historical channel was likely converting from a flowing channel to an abandoned meander. Fine sediment deposition and vegetation encroachment on the channel would have been expected. Meander abandonment by the active channel alignment occurred between 1940 and 1988.

Figure 5-6. A map of the assessment reach depicting the locations of several sites recommended for meander reactivation and meander abandonment prevention.

Activities specific to Site 2 would focus on preventing meander abandonment. As shown in Figure 5-6, an active floodplain avulsion channel has formed to the south of the primary meander and is conveying a substantial portion of the Sprague River discharge. To prevent a full meander cutoff, engineered log jams coupled with vegetated soil lifts would be constructed at the upstream end of the floodplain avulsion channel. The engineered log jams would act to deflect flows into

The option to reconnect this section of the Sprague River would be contingent on landowner approval and project feasibility. The project would increase channel length in the middle Sprague River by 3,315 ft from existing conditions. Additional survey work would be required to determine project feasibility. Possible limitations to project success would include the existing vegetation condition, sediment loading to the reach and sediment transport through the re-connected meander, and channel processes that would cause the future re-abandonment of the meander.

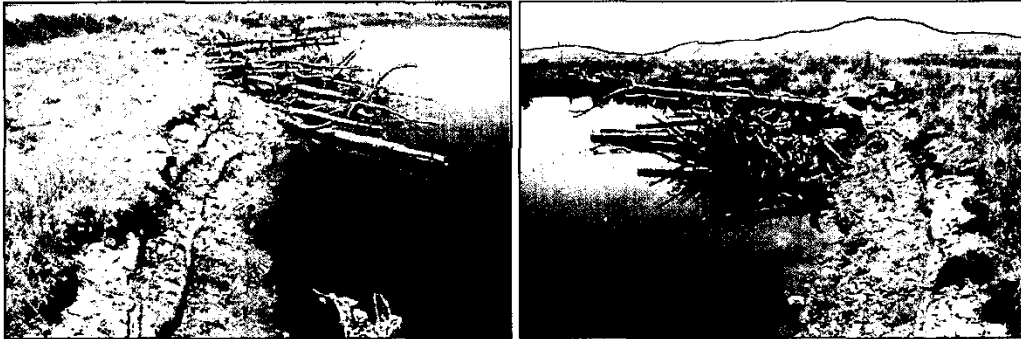
Figure 5-7. Examples of engineered log jams on the Sprague River. Upstream (left) and downstream (right) views of two structures illustrate the bank protection and aquatic habitat creation benefits of the structures. Willow cuttings planted in the soil lifts will provide additional bank stability and riparian habitat in the future.

Engineered log jams would be comprised of rootwads with attached stems as well as tree tops without attached rootwads. Rootwads would average 3 ft to 4 ft in fan diameter and have minimum stem lengths of 25 ft to 30 ft (Figure 5-7). Approximately 10 rootwads would be incorporated in each structure, along with multiple broken stems, logs, and branches to provide additional structure mass and aquatic habitat diversity. Each structure would be anchored with approximately 10 cubic yards of rock. A typical detail for an engineered log jam is presented on Sheet DT-1 in Appendix C.
