MIDDLE SPRAGUE RIVER ASSESSMENT AND FUGATT PROPERTY CONCEPTUAL DESIGN

River Design Group, Inc.

August, 2006

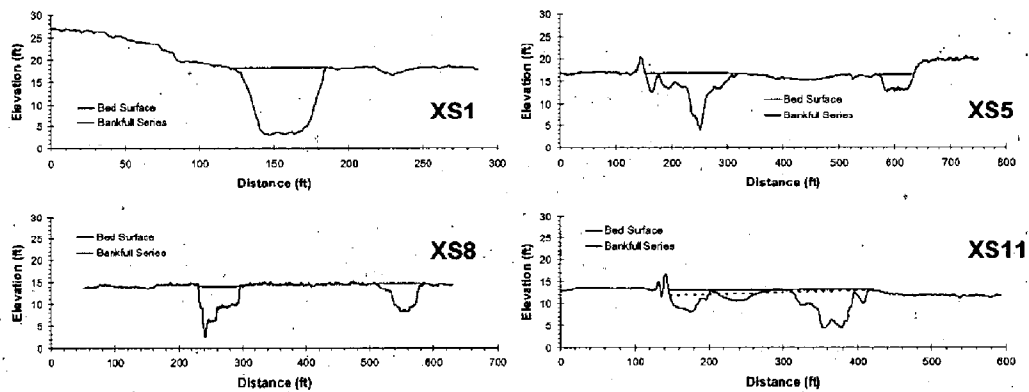
The existing channel morphology in the assessment reach was evaluated using the LIDAR dataset. Figure 3-5 shows the cross section location. Figure 3-6 illustrates example channel cross-sections. Table 3-4 compares the dimensions for the selected channel cross sections. In general, sampled locations characterized by a single channel had a smaller cross section area, narrower width, and a greater mean depth compared to multiple channel sites. Multiple channel sites were typically related to meander cut-off locations or where human activities had influenced the channel. Channel dimensions sampled from multiple channel sites generally had greater cross section areas, wider channels, and shallower mean depths. Maximum channel depths were similar between the two channel classes suggesting that flows maintain the maximum channel depth in both single and multiple channel locations. At three locations where the river has abandoned historical meanders (Cross section 5, Cross section 8, and Cross section 11), the historical channel segments have filled and the more recently formed avulsion channels maintain deeper and larger channels. Floodplain levees located on the west floodplain adjacent to the channel limits floodwater access to the floodplain.

Figure 3-6. Example channel cross sections from the assessment reach. XS1 represents an example single channel location. The other cross sections have multiple channels. Floodplain peaks on the left bank of XS5 and XS11 are floodplain levees. The graphs are vertically exaggerated. The distance for XS1 is substantially shorter than the other cross sections and therefore the channel image is magnified.

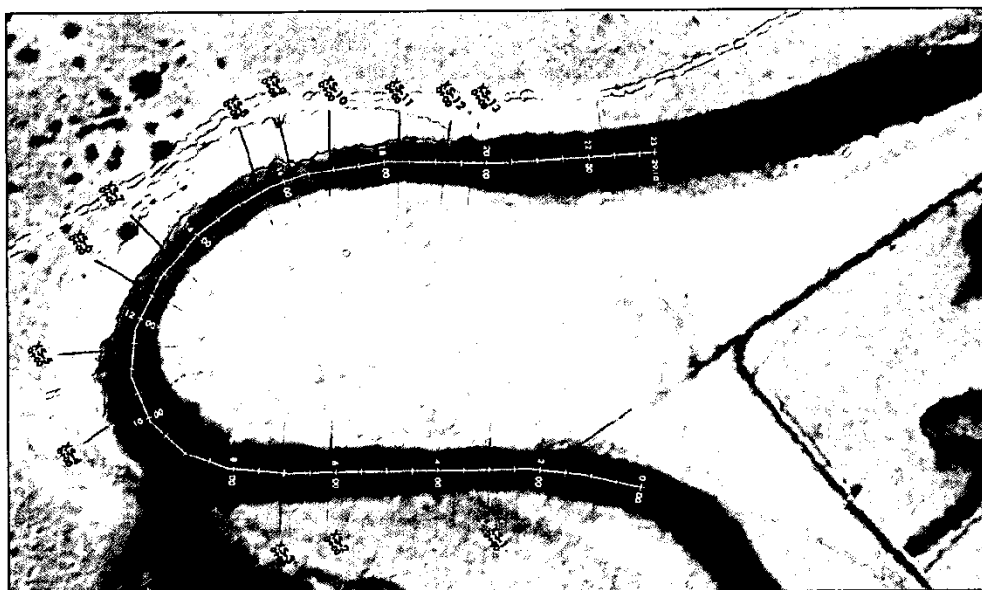
Thirteen cross sections were surveyed through the Fugatt property to characterize the existing channel conditions (Figure 4-3). Cross sections were located to evaluate the channel upstream of the terrace, through the terrace reach, and downstream from the terrace. In plan view, the channel width varies through the reach, especially at the start of the meander. The channel widening is associated with the interaction of the channel with the bedrock outcrop between Cross section 3 and Cross section 4. Table 4-1 displays the bankfull channel dimensions for each of the cross sections presented by subreach.

Figure 4-3. Channel cross section locations through the Fugatt reach. Cross sections were situated to evaluate the channel dimensions and how the channel dimensions adjust with the interaction with the clay hardpan from approximately station 11+00 to 18+00.

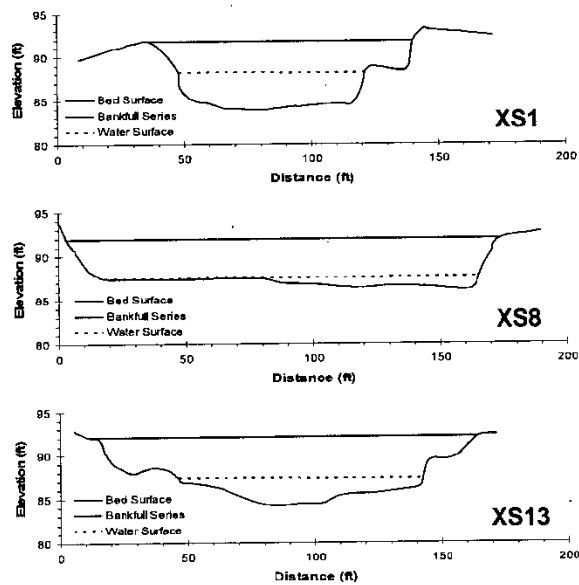
Typical channel cross sections representing the three sub-reaches are presented in Figure 4-4. Bankfull channel dimensions are presented in Table 4-2. Upstream of the meander, Cross section 1 is characterized by a narrow, deep channel with a vegetated bench below the bankfull elevation. Cross section 8, located downstream from the meander apex, has a wide, shallower morphology. The hardpan is exposed during low flows and does not support vegetation. The smooth surface of the hardpan also results in the efficient transport of bedload through the meander. Gravel in the reach is limited to the margin of the point bar. Cross section 13, located downstream of the terrace and hardpan channel feature, is again narrow and deep, similar to Cross section 1. The channel conditions through the property reflect the presence of the terrace and the hardpan.

Figure 4-4. Typical channel cross sections through the Fugatt property survey reach.

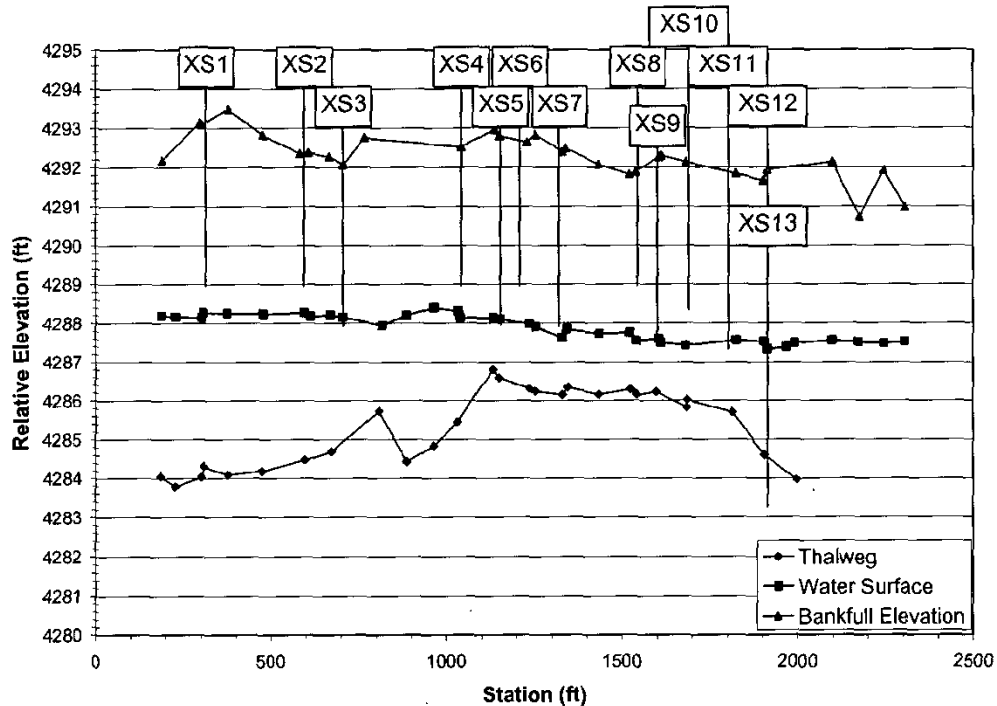
Figure 4-5. The channel profile through the Fugatt reach. The channel cross section locations are denoted by the numbered red boxes. The rise in the channel thalweg from station 11+50 through 18+25 shows where the clay hardpan forms the bed surface of the channel.

The bankfull channel slope is 0.0006 ft/ft. The water surface slope through the reach is 0.0004 ft/ft. The outside of the meander apex is the shallowest portion of the surveyed reach. The hardpan located through this section limits channel scour and pool formation.

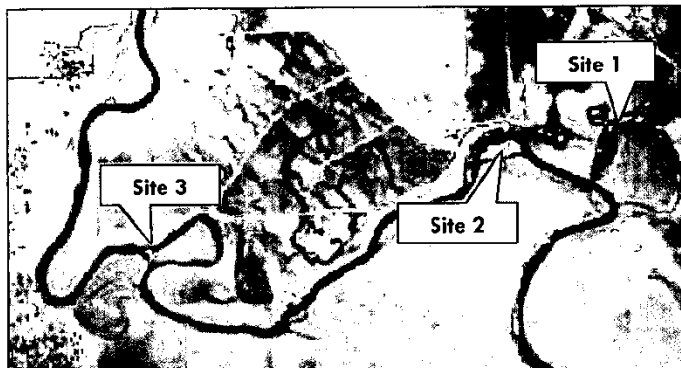
Site 1 was identified during the field assessment and occurs at station 120+00 in the project area (Figure 5-6). Based on the air photo analysis, the meander was disconnected from the primary Sprague River alignment between 1940 and 1998. However, by 1940, a majority of the primary flows were likely conveyed through the floodplain avulsion channel rather than the historical primary channel. The historical channel likely conveyed flow during all stages of the hydrograph. However, the historical channel was likely converting from a flowing channel to an abandoned meander. Fine sediment deposition and vegetation encroachment on the channel would have been expected. Meander abandonment by the active channel alignment occurred between 1940 and 1988.

Figure 5-6. A map of the assessment reach depicting the locations of several sites recommended for meander reactivation and meander abandonment prevention.

Activities specific to Site 2 would focus on preventing meander abandonment. As shown in Figure 5-6, an active floodplain avulsion channel has formed to the south of the primary meander and is conveying a substantial portion of the Sprague River discharge. To prevent a full meander cut-off, engineered log jams coupled with vegetated soil lifts would be constructed at the upstream end of the floodplain avulsion channel. The engineered log jams would act to deflect flows into

The option to reconnect this section of the Sprague River would be contingent on landowner approval and project feasibility. The project would increase channel length in the middle Sprague River by 3,315 ft from existing conditions. Additional survey work would be required to determine project feasibility. Possible limitations to project success would include the existing vegetation condition, sediment loading to the reach and sediment transport through the re-connected meander, and channel processes that would cause the future re-abandonment of the meander.
