Task Completion Report

Date: January 27, 2006 *Project Number:* 1530.03
Prepared By: Mike Gagner and Dudley Reiser *Trip Date:* October 17-20, 2005
Location: Upper Klamath River Basin
Distribution: M. Dammarell (BIA), B. Scott-Brier (DOI), D. Harder (DOJ), file

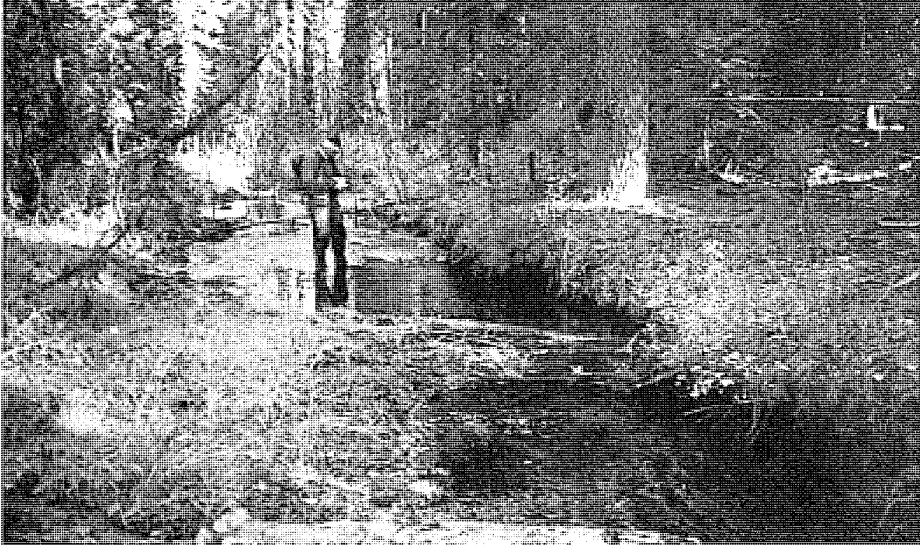
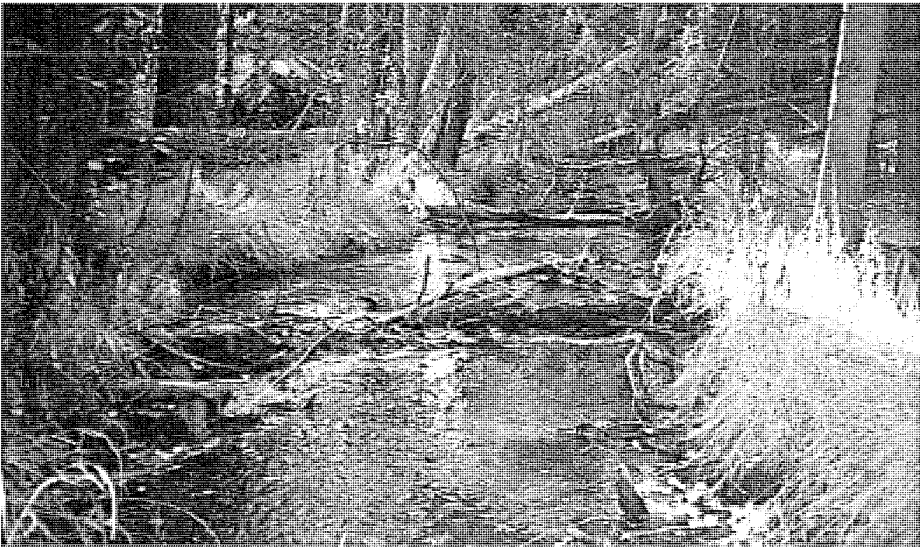
Scott Creek – 2005 Habitat Survey Reach

The fish habitat survey of Scott Creek was completed on October 20, 2005 at a stream flow of approximately 8 cubic feet per second (cfs) (Attachment C). The reach survey started at the Forest Service campground near the Klamath Tribes old reservation boundary (GPS N42.885389 W121.9925056) and continued upstream 3,700 feet to the western edge of Section 13 (GPS N42.88370 W121.937330). The average wetted width of the channel throughout the survey section was 14.5 feet. The reach was characterized by low to moderate gradient, moderate sinuosity, and low to moderate confinement. There were 70 habitat units within the reach, comprised of 24 percent riffle, 25 percent pool, and 51 percent run by length. Pool units were generally formed by lateral scour or LWD obstructions. Like Sand Creek, pool habitat in Scott Creek was generally complex providing multiple types of fish cover including undercut bank, overhanging vegetation, and object cover (i.e., LWD). The average maximum pool depth and residual pool depth were relatively high for this size of stream at 2.4 feet and 1.7 feet, respectively. Spawning sized gravels were the dominant substrate in 59 percent of the total survey area. However, Scott Creek had the least amount of potential spawning habitat of the three streams, with only 524 square feet (1% of total area). There was a large supply of LWD pieces found in the reach (311 pieces) providing excellent fish cover and channel complexity. Streambanks were lined by a thick stand of mature conifer and hardwood species.

In general, fish habitat attributes for Scott and Sand creeks would be categorized as average to good when compared to assessment benchmarks. Pool area, pool frequency, and the percentage of substrate comprised of sand-silt-organics were the only attributes that would fall below the “good” condition criteria. Habitat condition for these three attributes would be considered “average,” but they are much closer to the criteria used to define “good” habitat than those used to define “poor” habitat. Habitat conditions within the surveyed reaches of both Scott and Sand creeks indicate these streams provide good quality spawning, incubation, and rearing habitat for salmonid fishes. Unfortunately, neither of these streams is believed to currently support native salmonid fish species (e.g., redband or bull trout) (USFS unpublished report). Moreover, both of these streams are currently isolated from downstream connecting waters (i.e., Williamson River), eliminating the opportunity for natural recruitment of salmonid stocks from downstream waters.

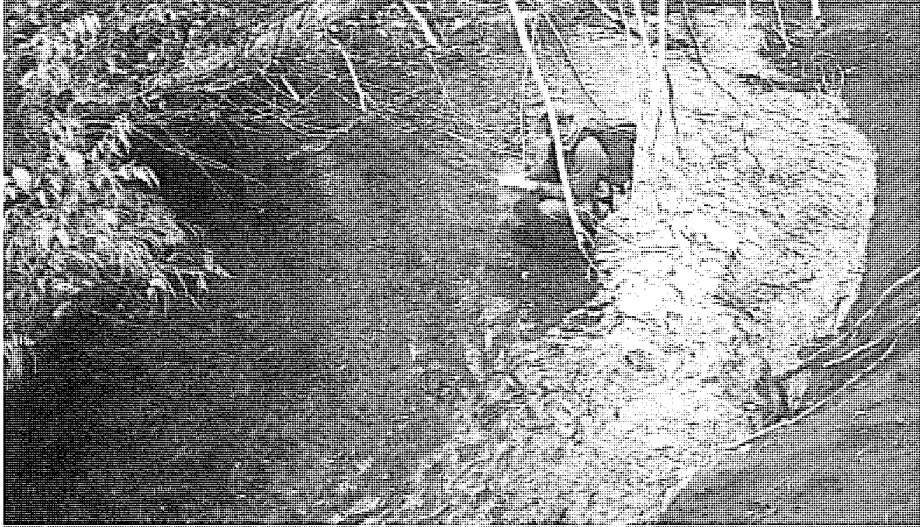
Sand Creek - 2005 Habitat Survey Reach

The Sand Creek habitat survey was completed on October 18, 2005 at a stream flow of approximately 16 cubic feet per second (cfs) (Attachment C). The survey reach began near the Klamath Tribes old reservation boundary (GPS N42.845821 W121.915609) and extended upstream 4,141 feet to near the center of Section 31 (GPS N42.839936 W121.929417). The average wetted width of the channel throughout the survey section was 39 feet. The reach was characterized by moderate gradient, low to moderate sinuosity, and moderate to high confinement by surrounding hill slopes. There were 69 habitat units within the reach, comprised of 56 percent riffle, 24 percent pool, and 20 percent run by length. Most pools in the reach were formed by scour around LWD pieces. All pool units in the reach contained LWD cover. Pool habitat was generally complex providing multiple types of fish cover including undercut bank,

overhanging vegetation, and object cover. Average maximum pool depth was relatively high for this size stream at approximately 2.7 feet. Residual depths were also relatively high averaging just over 1.8 feet. Spawning sized gravels comprised 77% of the surveyed reach; the remainder of the stream area (23%) was covered with sand (pumice), silt, or organic type substrates. There was a large supply of LWD found in the reach with 354 pieces counted during the survey. The streambanks were lined by a thick stand of mature conifer and hardwood species providing a good supply of LWD and shade.

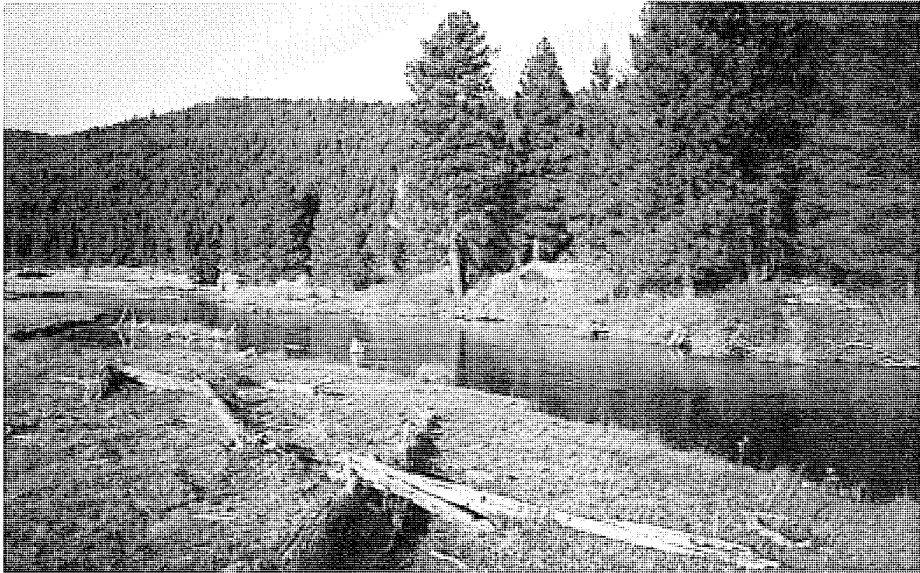
Wood River - 2005 Habitat Survey Reach

The Wood River habitat survey was completed on October 17, 2005 at a stream flow of approximately 155 cubic feet per second (cfs) (R2 staff gage reading). The survey reach began at Jackson Kimball State Park (GPS N42.739787 W121.979619) and extended downstream 5,390 feet to the Dixon Road crossing (GPS N42.733669 W121.988417). The average wetted width of the channel throughout the survey section was 130 feet. The reach was characterized by low gradient, relatively high sinuosity, and limited habitat diversity. There were only eight habitat units within the reach, which was made up of 70 percent glide, 17 percent pool, and 13 percent riffle by length. Although only two of the eight units in the reach were pools, they comprised 25 percent of the reach surface area. Both pools were formed by lateral scour on acute meander bends, but only one of the pools contained fish cover. The pools were relatively deep with maximum depth of 4.5 feet or greater. Average residual depth for the pools was just over 2.5 feet. Although spawning sized gravels were somewhat limited in the reach with only 25 percent of the stream area containing spawning substrate, there was an estimated 5,291 square feet of potential salmonid spawning area in the reach. The remainder of the stream bottom (75%) was covered with sand (pumis), silt, or organic type substrates. The total number of LWD pieces found in the reach was low with 78 pieces counted. This was not surprising since the riparian community consists primarily of grasses, willow, and only a few scattered large conifers. Cattle grazing effects were evident along both sides of the stream channel resulting in the loss of riparian vegetation, trampling of stream banks, and compaction of streamside soils.

For the Wood River, the categories of pool frequency, percent substrate comprised of sand-silt-organics, frequency of LWD, and bank vegetation protection were all characterized as in “poor” condition when compared to habitat condition benchmarks. Pool complexity and residual pool depth were the only attributes to be considered in “good” condition. Pool area and percent gravel composition fell in the “average” range. There are several possible reasons for the “poor” habitat

ratings including, proximity of the survey reach to the source spring, high percentage of pumice in the surrounding bedform material, the effects of grazing, and the sampled reach flows through a meadow area that is largely devoid of riparian vegetation. The downstream third of the survey reach does provide considerable spawning potential with over 5,000 square feet of suitable spawning area identified during the survey; redband trout spawning has been observed on numerous occasions in this section (R2 Trip Report 2004). In addition to providing important spawning habitat, the reach extends just downstream from the major source of spring-fed flow of the Wood River and therefore provides a large, stable source of good quality water that supports and promotes salmonid production in downstream reaches.
